## Ontario Structure Inspection Manual – Inspection Form

Structure Name	Savignac Road Bridge		
Main Highway #	N/A	On <input type="checkbox"/> Under <input type="checkbox"/>	Service on Structure: <input type="checkbox"/> Navig. Water <input type="checkbox"/> Non-Navig. Water <input type="checkbox"/> Rail <input checked="" type="checkbox"/> Road <input type="checkbox"/> Ped. <input type="checkbox"/> Other
Location description	2.45 km South of Leclair Road	Service under <input type="checkbox"/> Navig. Water <input checked="" type="checkbox"/> Non-Navig. Water <input type="checkbox"/> Rail <input type="checkbox"/> Road <input type="checkbox"/> Ped. <input type="checkbox"/> Other	
Owner/Custodian	Municipality of West Nipissing	Latitude: 46.355783	Longitude: -80.101927
MTO Region	Northern	Heritage Designation: <input type="checkbox"/> Not Cons. <input type="checkbox"/> Cons./not App. <input type="checkbox"/> List/not Desig <input type="checkbox"/> Desig./notList <input type="checkbox"/> Desig. & List

Field Inspection Information:			
Date of Inspection:	October 30, 2023	Type of Inspection	<input checked="" type="checkbox"/> Reg. OSIM <input type="checkbox"/> Enh. OSIM
Inspected By:	Matt

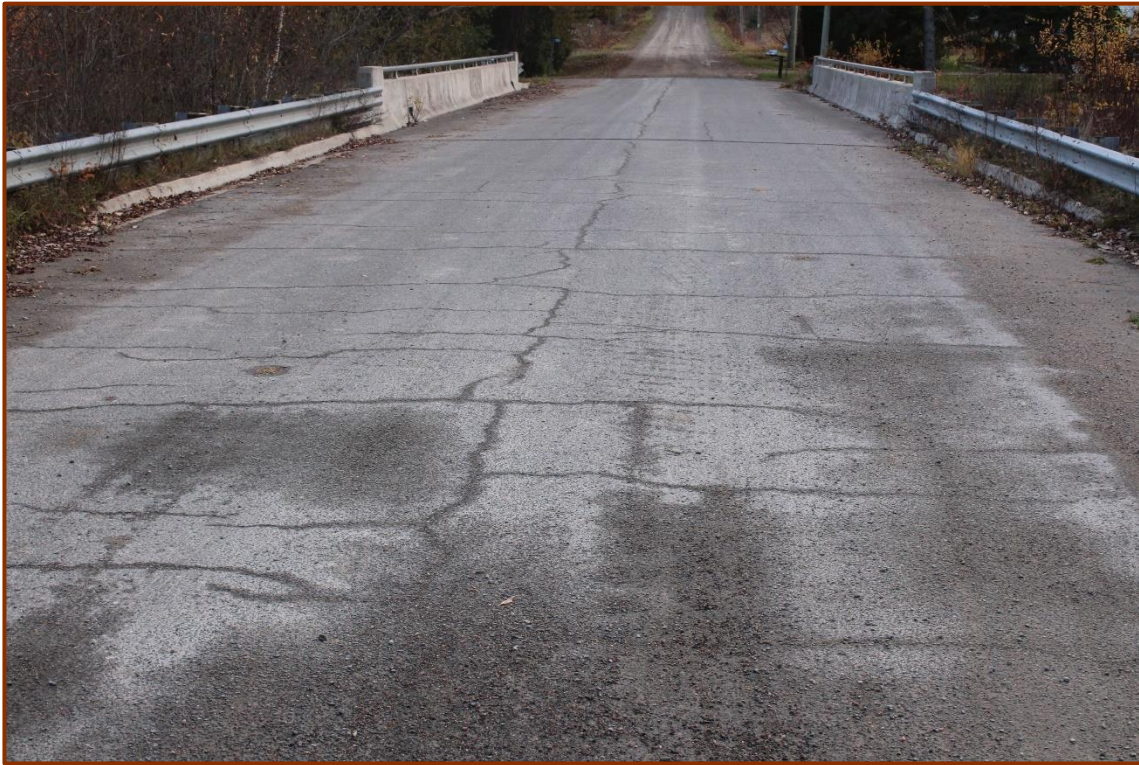
**1. B-007 2023-10-31 North Approach Looking South**

<b>Element Group:</b>	Approaches	<b>Length:</b>	6.0 m			
<b>Element Name:</b>	Wearing Surface	<b>Width:</b>	8.5 m			
<b>Location:</b>	North and South	<b>Height:</b>	N/A			
<b>Material:</b>	Asphalt	<b>Count:</b>	2			
<b>Element Type:</b>	Cast-In-Place	<b>Total Quantity:</b>	102 m <sup>2</sup>			
<b>Environment:</b>	<input type="checkbox"/> Benign <input type="checkbox"/> Moderate <input checked="" type="checkbox"/> Severe		<b>Inspected:</b>			Yes <input type="checkbox"/> No <input type="checkbox"/> Limited <input type="checkbox"/>
<b>Protection System:</b>						<b>Perform. Deficiencies</b>
<b>Condition</b>	<b>Units</b>	<b>Exc.</b>	<b>Good</b>	<b>Fair</b>	<b>Poor*</b>	
<b>Data:</b>	<input checked="" type="checkbox"/> m <sup>2</sup> <input type="checkbox"/> m <input type="checkbox"/> each <input type="checkbox"/> % <input type="checkbox"/> all		94	6	2	00
<b>Comments:</b>						
Medium to wide cracks at paved over joints. Medium transverse and longitudinal cracks noted.

<b>Recommended Work:</b>		<input type="checkbox"/> Rehab <input type="checkbox"/> Replace <input type="checkbox"/> 1-5 years <input type="checkbox"/> 6-10 years		<b>Maintenance Needs: 05</b>		
				<input type="checkbox"/> Urgent <input type="checkbox"/> 1 year <input checked="" type="checkbox"/> 2 year		
				Saw cut asphalt and seal with joint compound

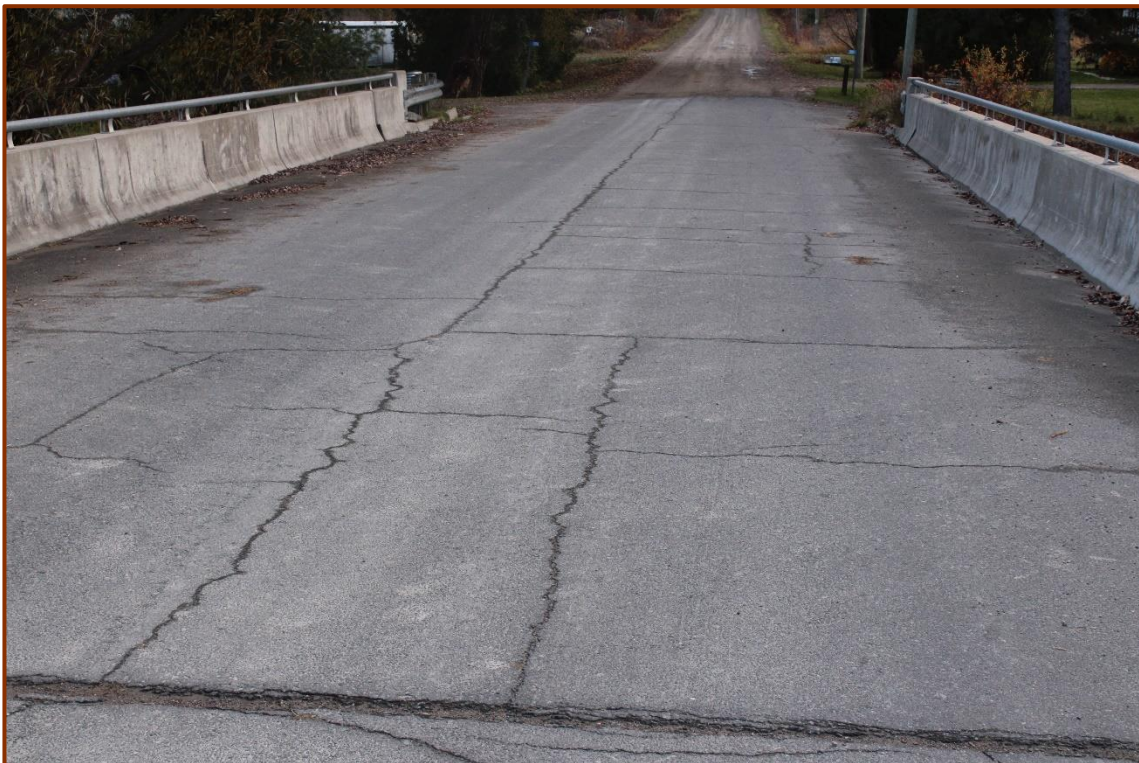
**2. B-007 2023-10-31 Deck Wearing Surface Looking South**

<b>Element Group:</b>	Deck	<b>Length:</b>	19.45 m			
<b>Element Name:</b>	Wearing Surface	<b>Width:</b>	8.5 m			
<b>Location:</b>		<b>Height:</b>	N/A			
<b>Material:</b>	Asphalt	<b>Count:</b>	N/A			
<b>Element Type:</b>		<b>Total Quantity:</b>	165.33 m <sup>2</sup>			
<b>Environment:</b>	<input type="checkbox"/> Benign <input checked="" type="checkbox"/> Moderate <input type="checkbox"/> Severe		<b>Inspected:</b>			Yes <input checked="" type="checkbox"/> No <input type="checkbox"/> Limited <input type="checkbox"/>
<b>Protection System:</b>						<b>Perform. Deficiencies</b>
<b>Condition</b>	<b>Units</b>	<b>Exc.</b>	<b>Good</b>	<b>Fair</b>	<b>Poor*</b>	
<b>Data:</b>	<input checked="" type="checkbox"/> m <sup>2</sup> <input type="checkbox"/> m <input type="checkbox"/> each <input type="checkbox"/> % <input type="checkbox"/> all		149.33	16		00
<b>Comments:</b>						
Medium longitudinal centreline cracks. Medium transverse cracks noted.

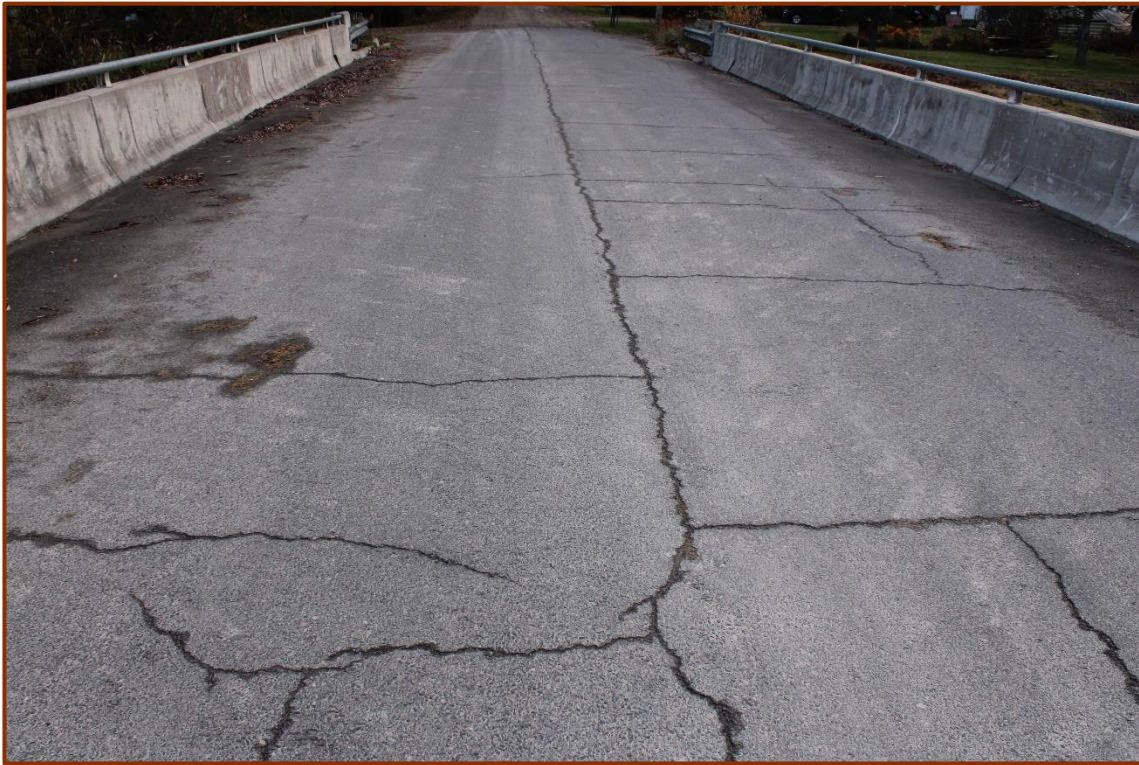
**3. B-007 2023-10-31** Centerline and Transverse Cracks in Wearing Surface

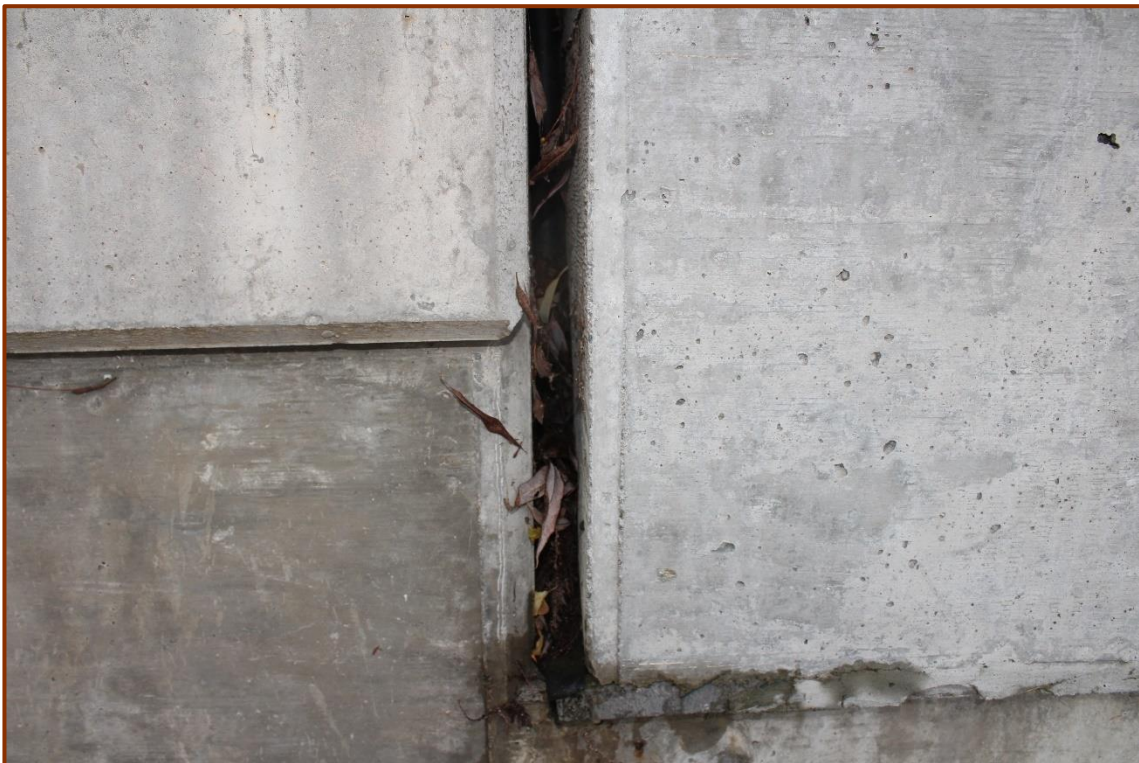
**4. B-007 2023-10-31** Debris in South Joint

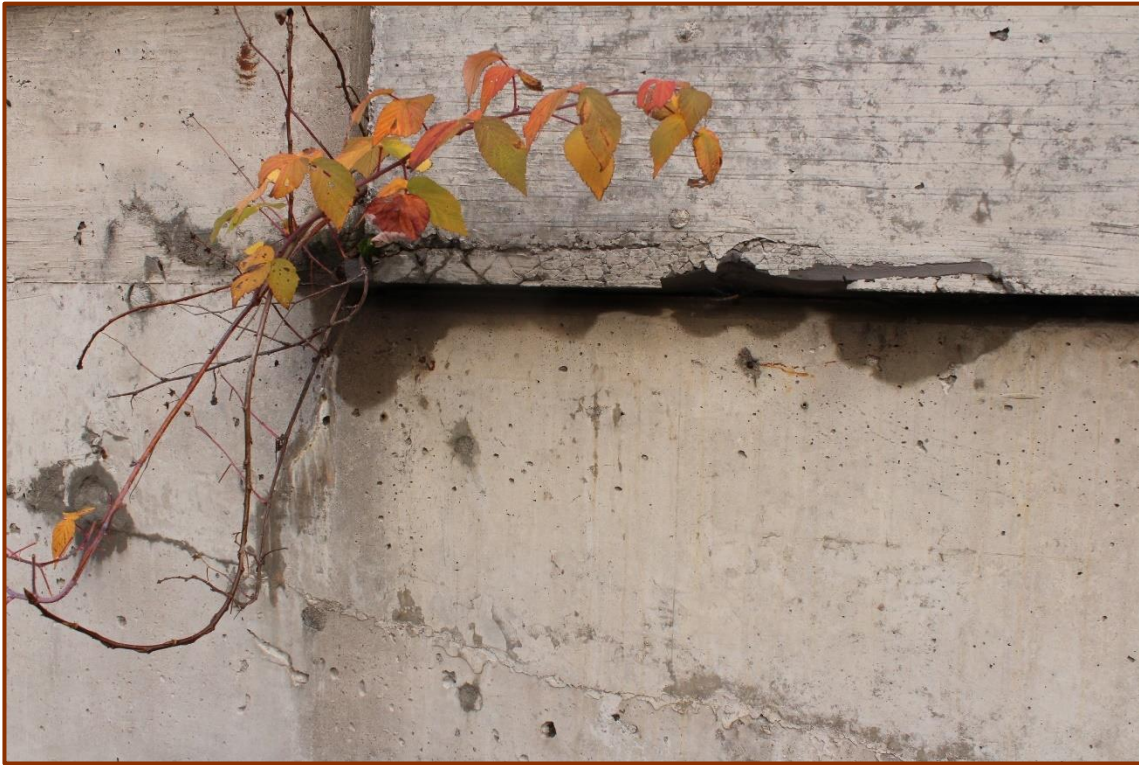
**5. B-007 2023-10-31** Joint Leaking at Northwest

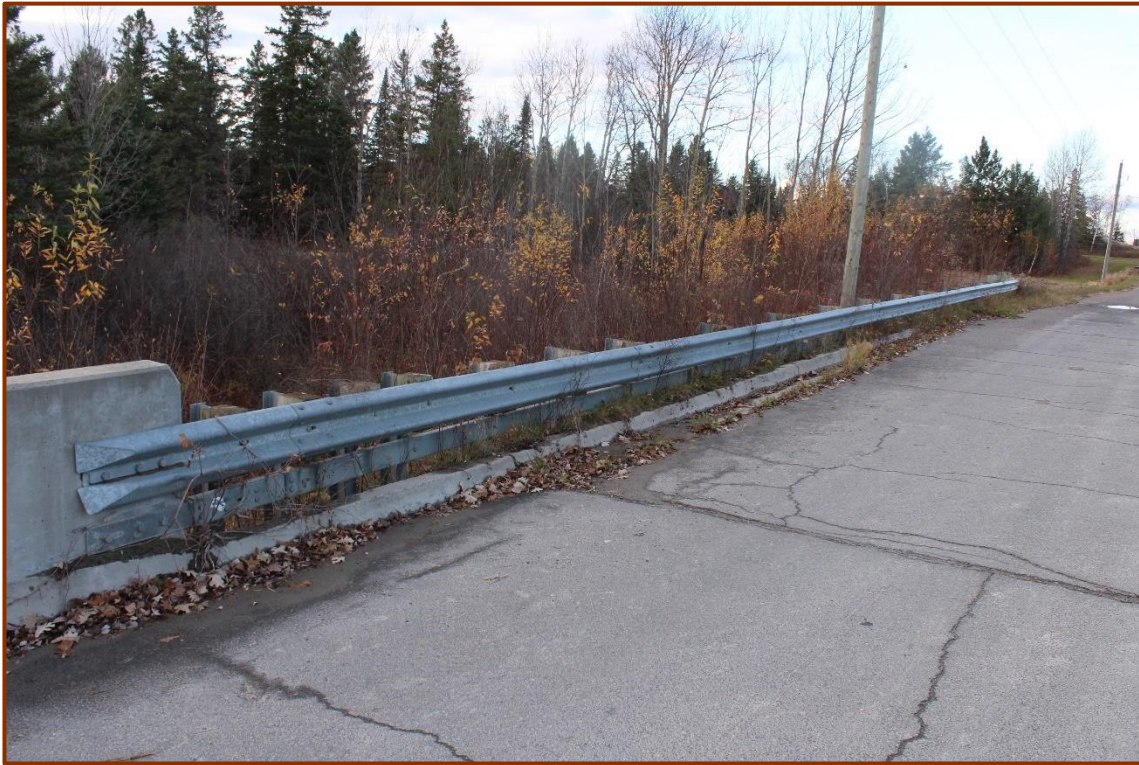
**7. B-007 2023-10-31 Northwest Guiderrail**

Rail attachment to barrier wall is bent at NW.						
<b>Recommended Work:</b>		<input type="checkbox"/> Rehab <input type="checkbox"/> Replace <input type="checkbox"/> 1-5 years <input type="checkbox"/> 6-10 years		<b>Maintenance Needs: 18</b>		
				<input checked="" type="checkbox"/> Urgent <input type="checkbox"/> 1 year <input type="checkbox"/> 2 year		
				Repair barriers at approaches Reattach flex beam to posts.

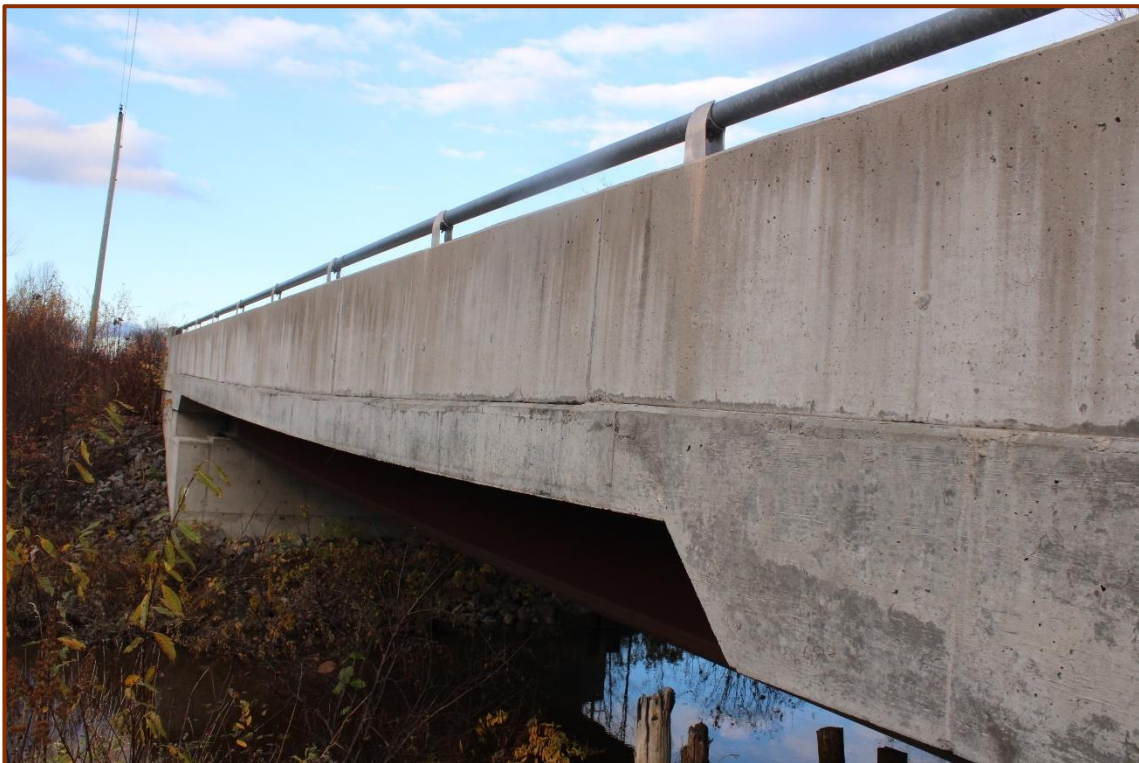
<b>Element Group:</b>	Barriers	<b>Length:</b>	26 m			
<b>Element Name:</b>	Barrier Walls – Exterior	<b>Width:</b>	N/A			
<b>Location:</b>	East and West	<b>Height:</b>	0.8 m			
<b>Material:</b>	Concrete	<b>Count:</b>	2			
<b>Element Type:</b>	Cast-In-Place	<b>Total Quantity:</b>	41.6 m <sup>2</sup>			
<b>Environment:</b>	<input type="checkbox"/> Benign <input checked="" type="checkbox"/> Moderate <input type="checkbox"/> Severe		<b>Inspected:</b>			Yes <input type="checkbox"/> No <input type="checkbox"/> Limited <input checked="" type="checkbox"/>
<b>Protection System:</b>	N/A					<b>Perform. Deficiencies</b>
<b>Condition</b>	<b>Units</b>	<b>Exc.</b>	<b>Good</b>	<b>Fair</b>	<b>Poor*</b>	
<b>Data:</b>	<input checked="" type="checkbox"/> m <sup>2</sup> <input type="checkbox"/> m <input type="checkbox"/> each <input type="checkbox"/> % <input type="checkbox"/> all		41.1	0.5		00
<b>Comments:</b>						
Generally in good condition. Hairline to narrow cracks with efflorescence.

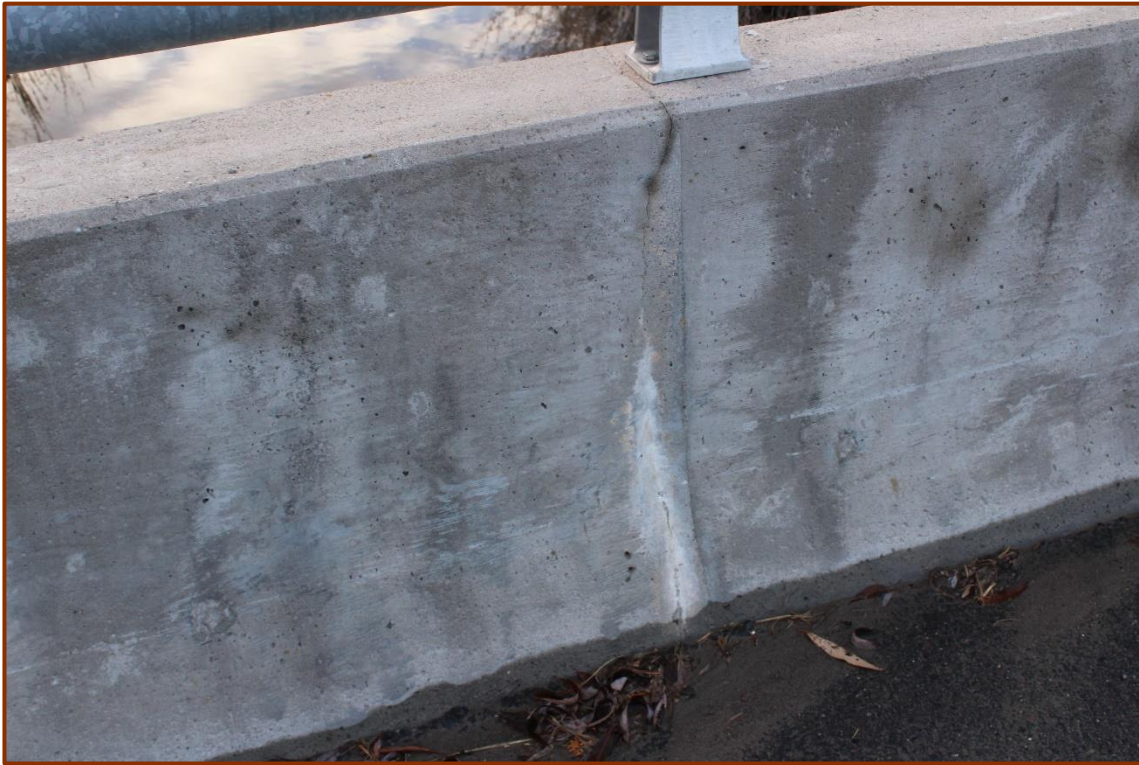
**13. B-007 2023-10-31** Crack with Efflorescence in West Barrier

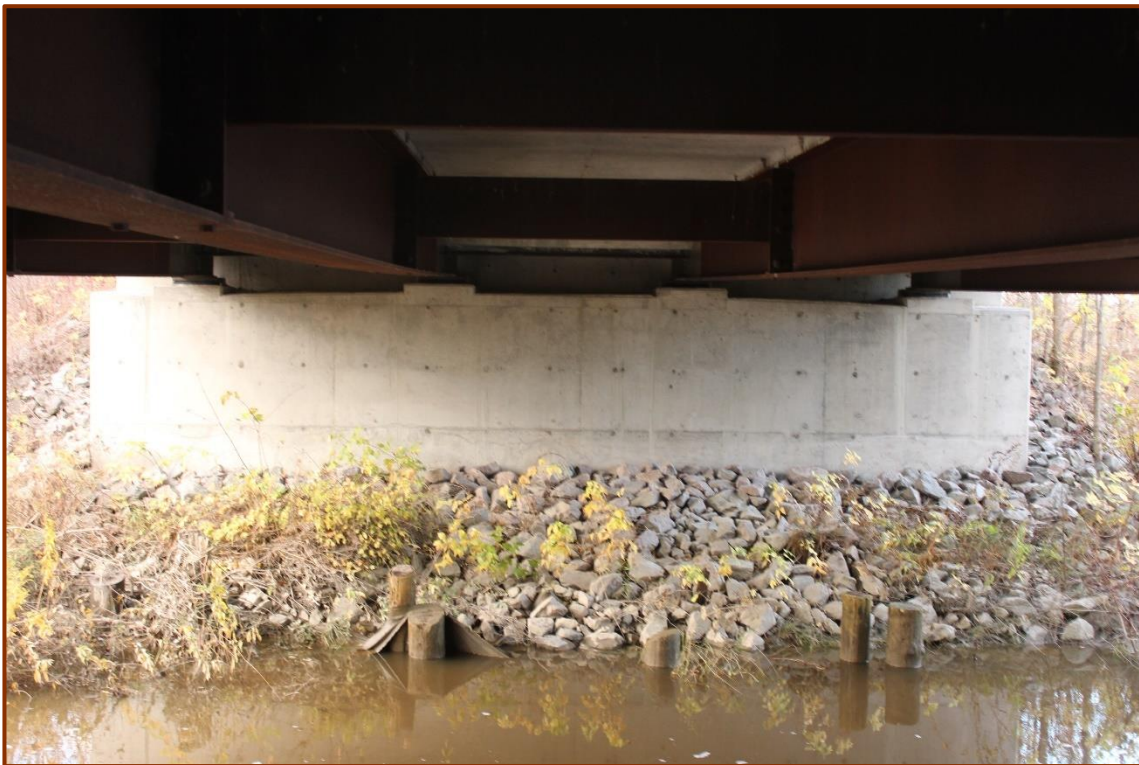
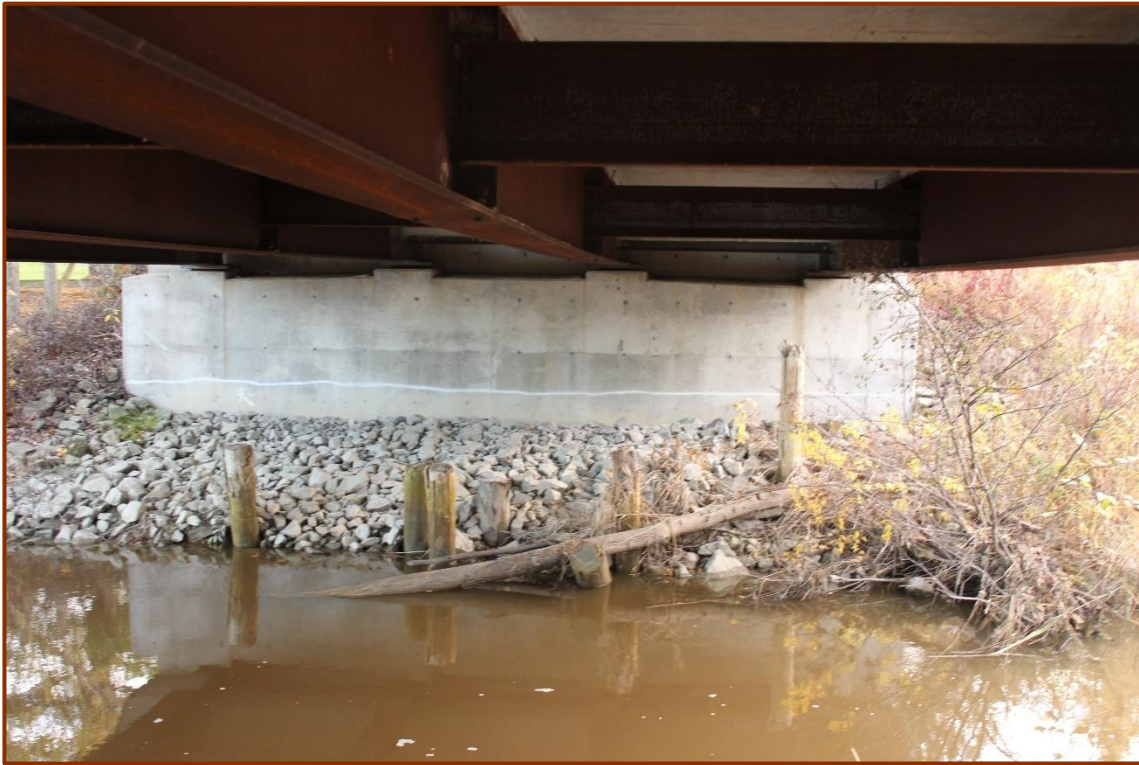
29.14			00
<b>Comments:</b>  Hairline cracks noted at both abutments.						
<b>Recommended Work:</b>			<b>Maintenance Needs:</b> 00			
<input type="checkbox"/> Rehab <input type="checkbox"/> Replace <input type="checkbox"/> 1-5 years <input type="checkbox"/> 6-10 years			<input type="checkbox"/> Urgent <input type="checkbox"/> 1 year <input type="checkbox"/> 2 year

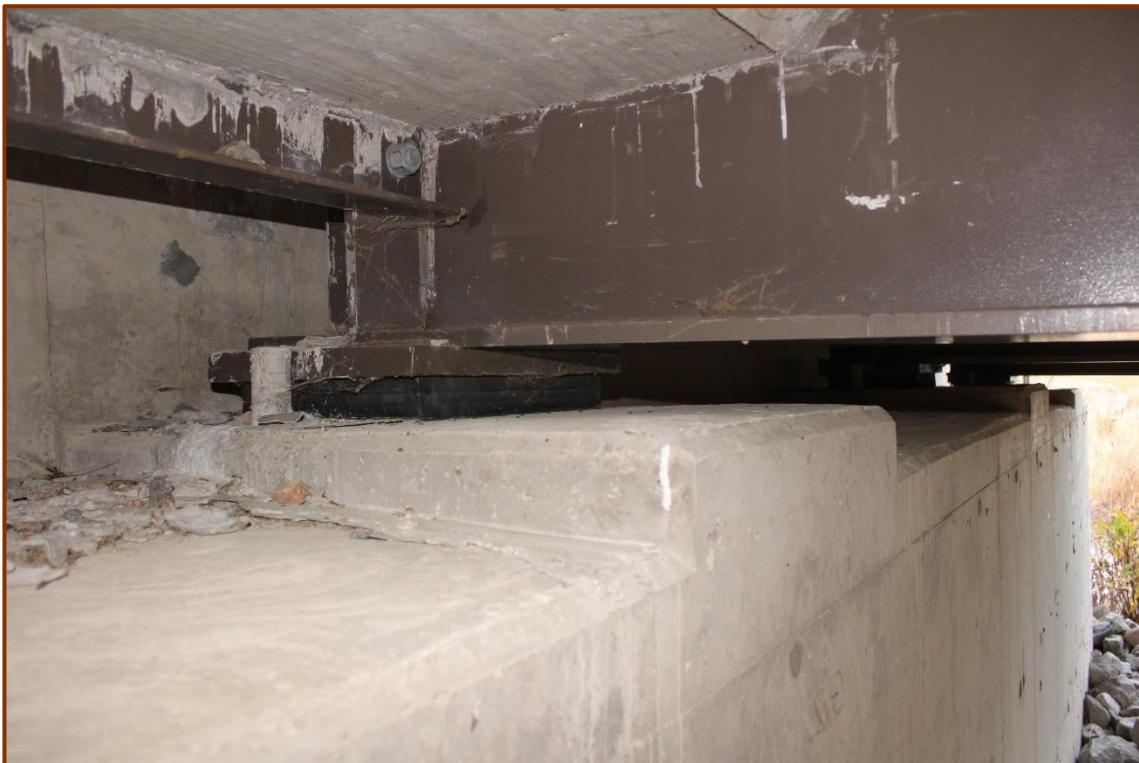
<b>Element Group:</b>	Abutments	<b>Length:</b>	N/A			
<b>Element Name:</b>	Bearings	<b>Width:</b>	N/A			
<b>Location:</b>	North and South	<b>Height:</b>	N/A			
<b>Material:</b>	Laminated Elastomeric	<b>Count:</b>	8			
<b>Element Type:</b>	Bearing Pad	<b>Total Quantity:</b>	8			
<b>Environment:</b>	<input checked="" type="checkbox"/> Benign <input type="checkbox"/> Moderate <input type="checkbox"/> Severe		<b>Inspected:</b> Yes <input checked="" type="checkbox"/> No <input type="checkbox"/> Limited <input type="checkbox"/>			
<b>Protection System:</b>	N/A					<b>Perform. Deficiencies</b>
<b>Condition</b>	<b>Units</b>	<b>Exc.</b>	<b>Good</b>	<b>Fair</b>	<b>Poor*</b>	
<b>Data:</b>	<input type="checkbox"/> m <sup>2</sup> <input type="checkbox"/> m <input checked="" type="checkbox"/> each <input type="checkbox"/> % <input type="checkbox"/> all		8			00
<b>Comments:</b>						
Generally in good condition.

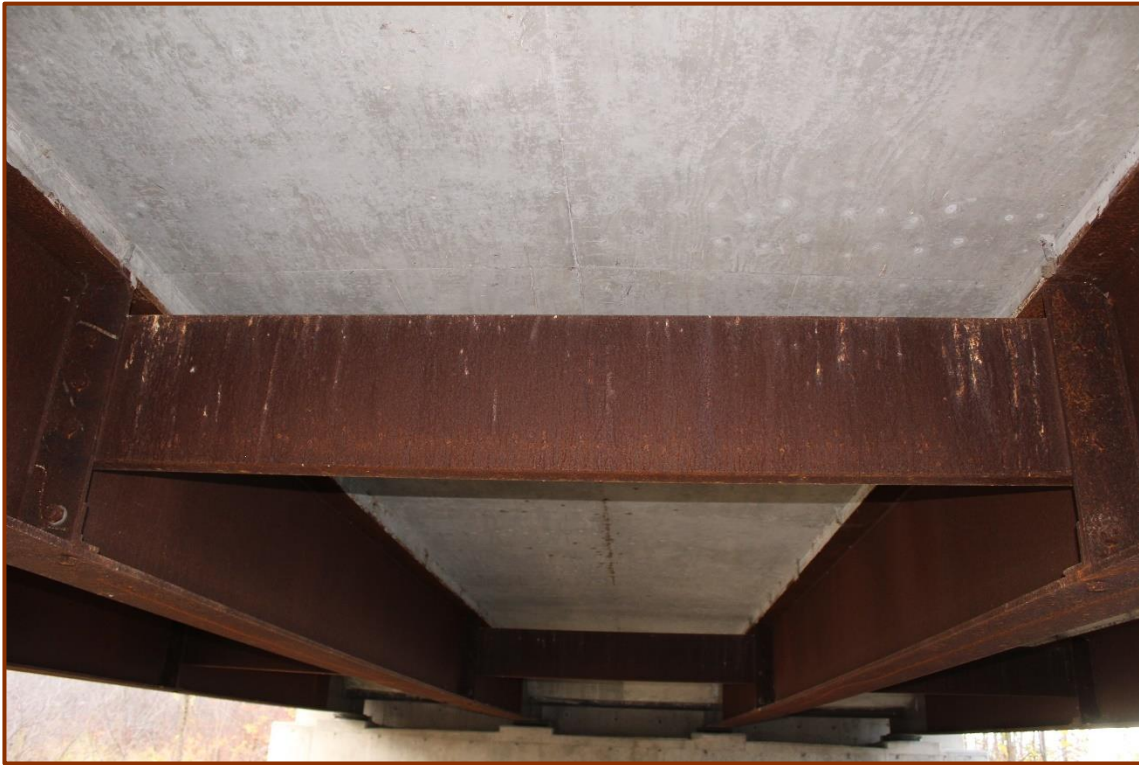
<b>Element Group:</b>	Beams/MLE's	<b>Length:</b>	2.5 m			
<b>Element Name:</b>	Diaphragms – Intermediate	<b>Width:</b>	0.086 m			
<b>Location:</b>	North and South	<b>Height:</b>	0.381 m			
<b>Material:</b>	Steel	<b>Count:</b>	6			
<b>Element Type:</b>	C380x50	<b>Total Quantity:</b>	6			
<b>Environment:</b>	<input checked="" type="checkbox"/> Benign <input type="checkbox"/> Moderate <input type="checkbox"/> Severe	<b>Inspected:</b>	Yes <input type="checkbox"/> No <input type="checkbox"/> Limited <input checked="" type="checkbox"/>			
<b>Protection System:</b>	N/A					<b>Perform. Deficiencies</b>
<b>Condition</b>	<b>Units</b>	<b>Exc.</b>	<b>Good</b>	<b>Fair</b>	<b>Poor*</b>	
<b>Data:</b>	<input type="checkbox"/> m <sup>2</sup> <input type="checkbox"/> m <input checked="" type="checkbox"/> each <input type="checkbox"/> % <input type="checkbox"/> all		6			00
<b>Comments:</b>						
Light surface rusting

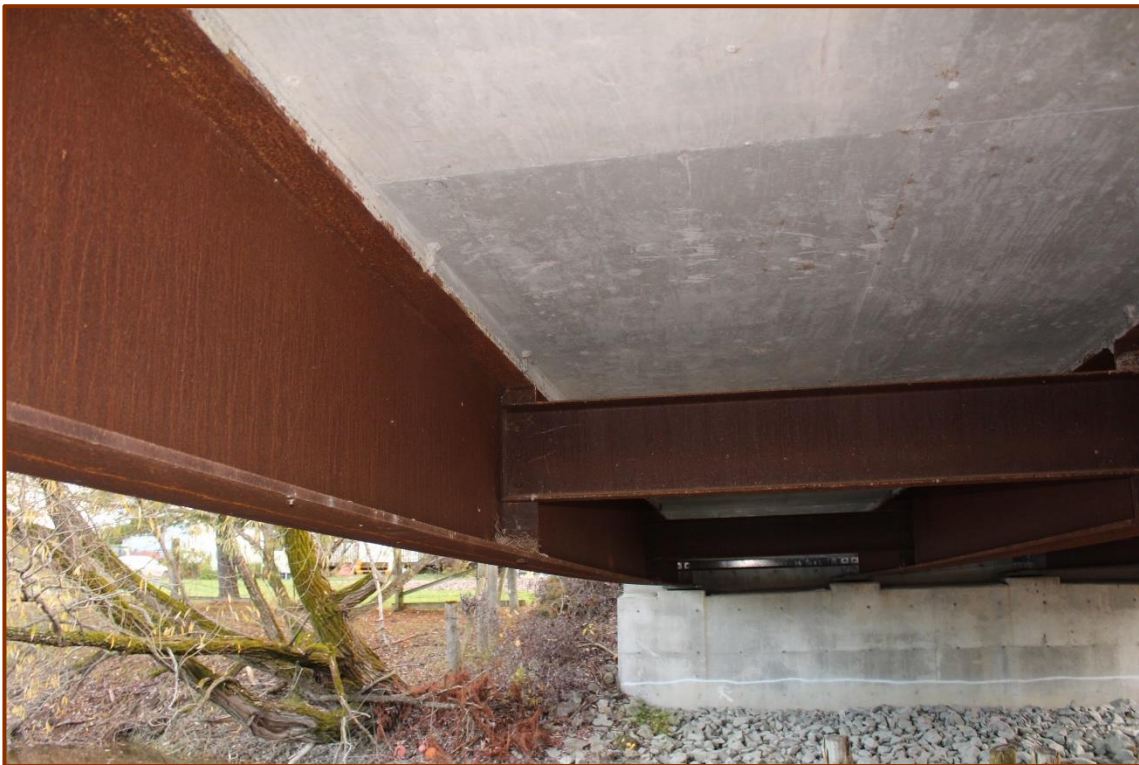
<b>Element Group:</b>	Beams/MLE's	<b>Length:</b>	1.4 m			
<b>Element Name:</b>	Girders– Ends	<b>Width:</b>	0.3 m			
<b>Location:</b>	North and South	<b>Height:</b>	0.7 m			
<b>Material:</b>	Steel (350AT)	<b>Count:</b>	8			
<b>Element Type:</b>	WWF 700x152	<b>Total Quantity:</b>	25.8 m <sup>2</sup>			
<b>Environment:</b>	<input checked="" type="checkbox"/> Benign <input type="checkbox"/> Moderate <input type="checkbox"/> Severe	<b>Inspected:</b>	Yes <input type="checkbox"/> No <input type="checkbox"/> Limited <input checked="" type="checkbox"/>			
<b>Protection System:</b>	Coated					<b>Perform. Deficiencies</b>
<b>Condition</b>	<b>Units</b>	<b>Exc.</b>	<b>Good</b>	<b>Fair</b>	<b>Poor*</b>	
<b>Data:</b>	<input checked="" type="checkbox"/> m <sup>2</sup> <input type="checkbox"/> m <input type="checkbox"/> each <input type="checkbox"/> % <input type="checkbox"/> all		25.8			00
<b>Comments:</b>						
Generally in good condition. Bird nest noted close to mid-span.

**20. B-007 2023-10-31** Birds Nest on Girder

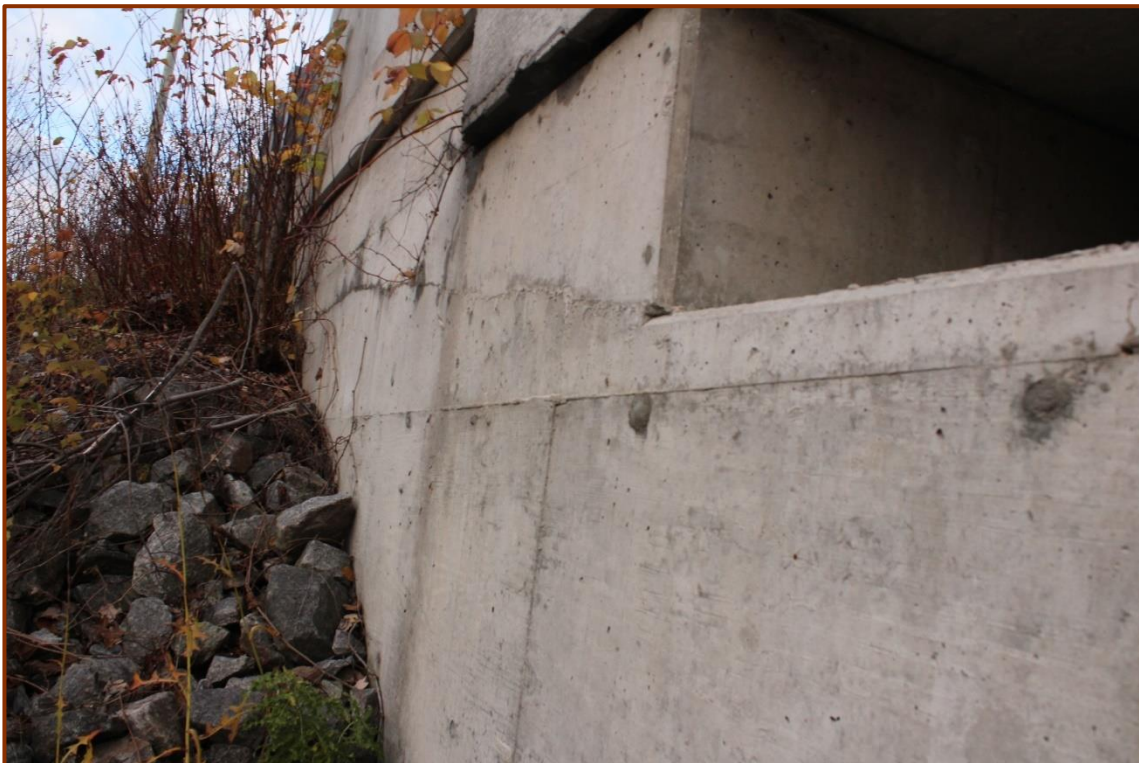
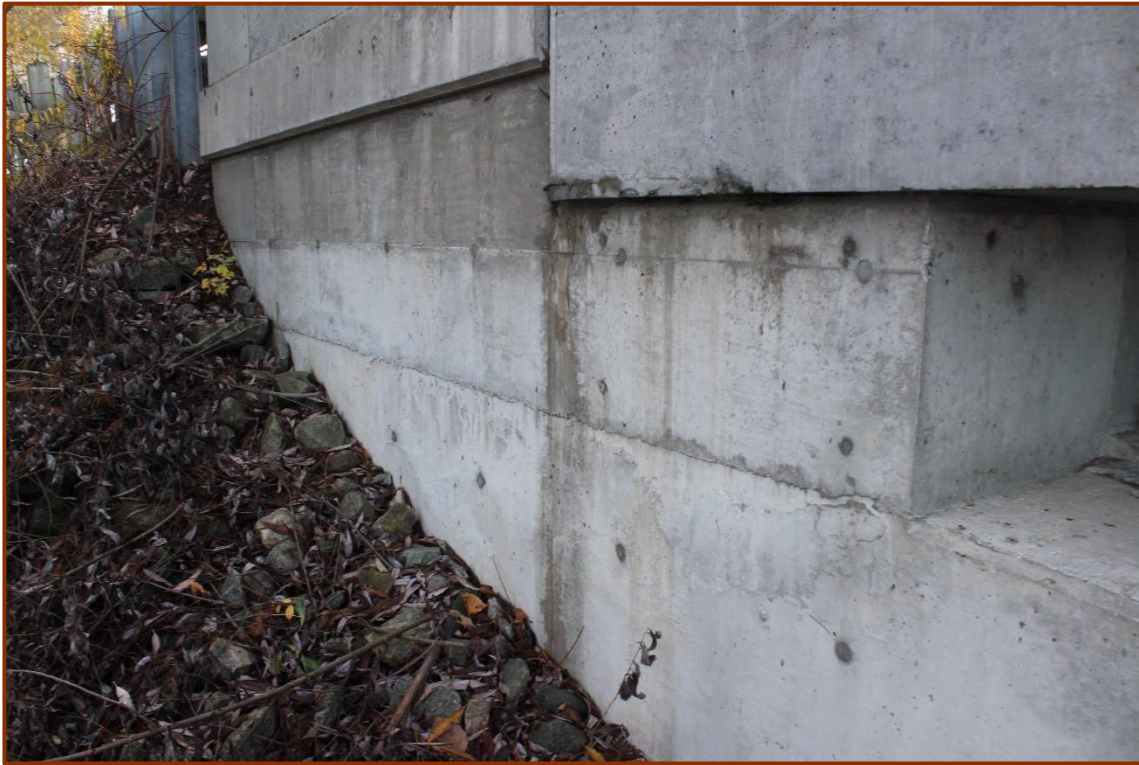
<b>Element Group:</b>	Abutments	<b>Length:</b>	4.5 m			
<b>Element Name:</b>	Wingwalls	<b>Width:</b>	N/A			
<b>Location:</b>	North and South	<b>Height:</b>	1.5 m			
<b>Material:</b>	Concrete	<b>Count:</b>	4			
<b>Element Type:</b>	Cast-In-Place	<b>Total Quantity:</b>	27 m <sup>2</sup>			
<b>Environment:</b>	<input checked="" type="checkbox"/> Benign <input type="checkbox"/> Moderate <input type="checkbox"/> Severe		<b>Inspected:</b> Yes <input checked="" type="checkbox"/> No <input type="checkbox"/> Limited <input type="checkbox"/>			
<b>Protection System:</b>	N/A					<b>Perform. Deficiencies</b>
<b>Condition</b>	<b>Units</b>	<b>Exc.</b>	<b>Good</b>	<b>Fair</b>	<b>Poor*</b>	
<b>Data:</b>	<input checked="" type="checkbox"/> m <sup>2</sup> <input type="checkbox"/> m <input type="checkbox"/> each <input type="checkbox"/> % <input type="checkbox"/> all		26.25	0.75		00
<b>Comments:</b>						
Crack with efflorescence at NW + SE wingwall.

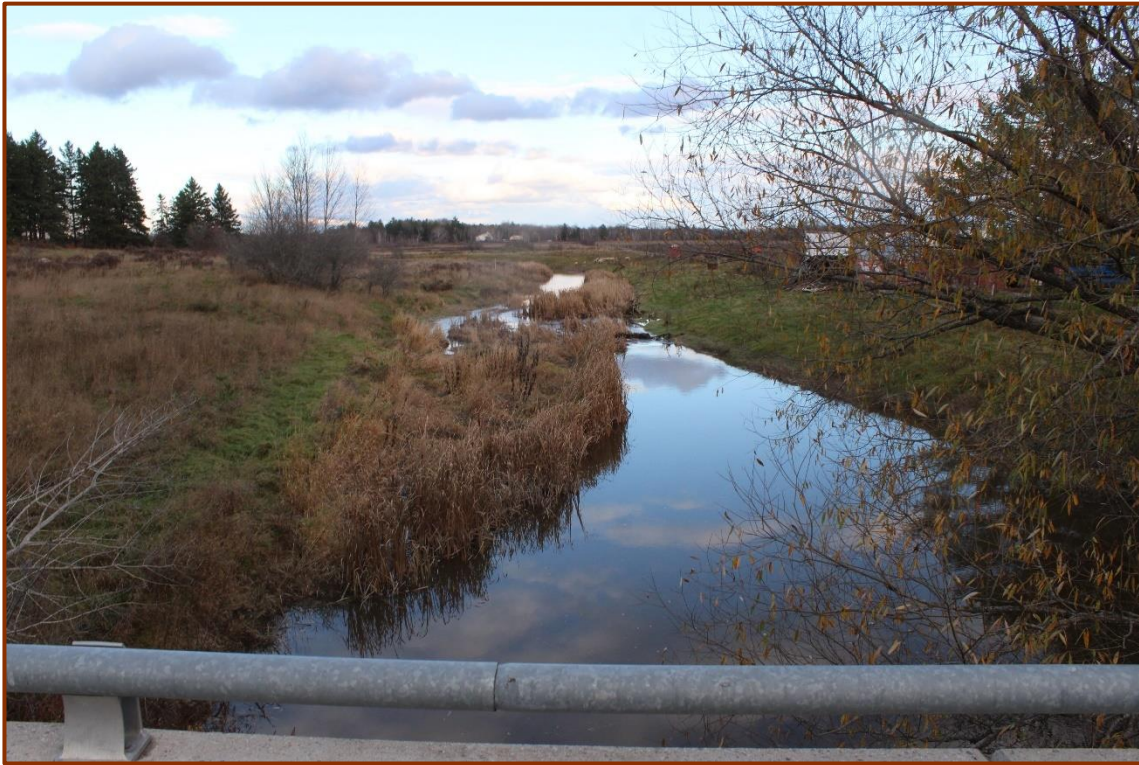
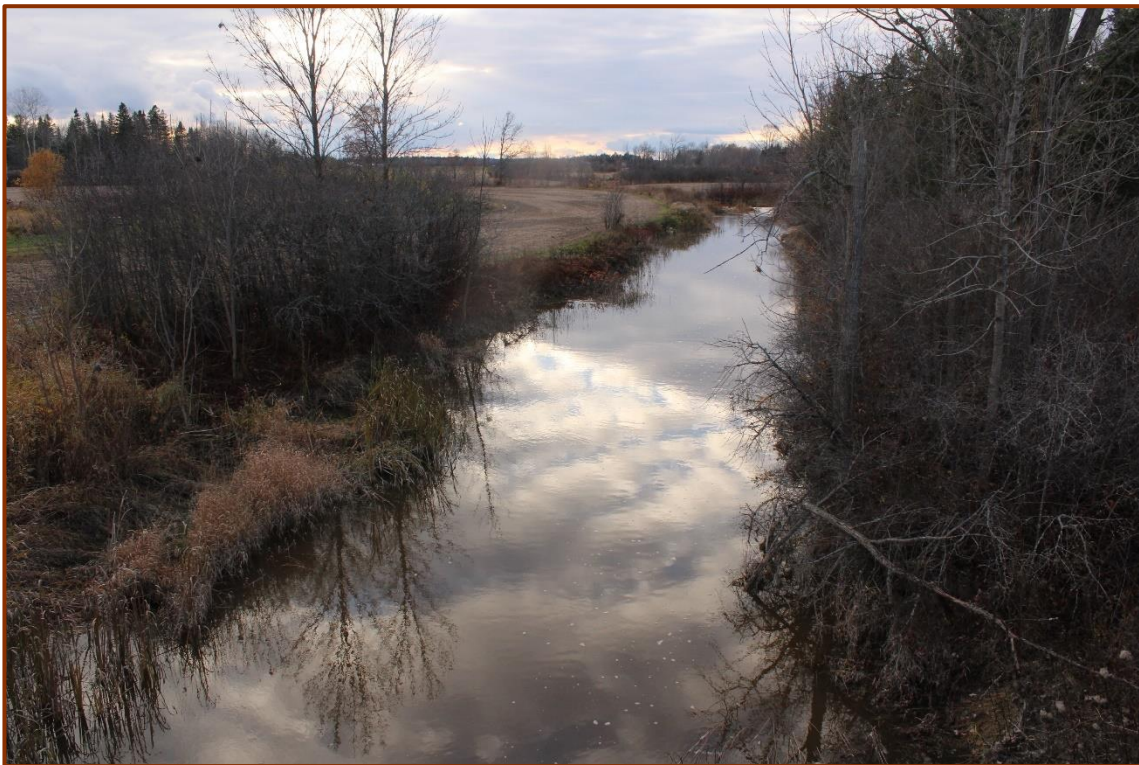
<b>Element Group:</b>	Embankments & streams	<b>Length:</b>	N/A			
<b>Element Name:</b>	Streams and waterways	<b>Width:</b>	N/A			
<b>Location:</b>	Under structure	<b>Height:</b>	N/A			
<b>Material:</b>	Native soil	<b>Count:</b>	1			
<b>Element Type:</b>	Stream	<b>Total Quantity:</b>	1			
<b>Environment:</b>	<input checked="" type="checkbox"/> Benign <input type="checkbox"/> Moderate <input type="checkbox"/> Severe		<b>Inspected:</b> Yes <input checked="" type="checkbox"/> No <input type="checkbox"/> Limited <input type="checkbox"/>			
<b>Protection System:</b>	Treated					<b>Perform. Deficiencies</b>
<b>Condition</b>	<b>Units</b>	<b>Exc.</b>	<b>Good</b>	<b>Fair</b>	<b>Poor*</b>	
<b>Data:</b>	<input type="checkbox"/> m <sup>2</sup> <input type="checkbox"/> m <input type="checkbox"/> each <input type="checkbox"/> % <input checked="" type="checkbox"/> all		All			00
<b>Comments:</b>  Flow is from west to east. Flow clearance was ±2.5m at the time of inspection.
