Ontario Structure Inspection Manual – Inspection Form

Structure Name	Centennial Bridge (Leclair Road Bridge over Veuve River)		
Main Highway #	N/A	On <input type="checkbox"/> Under <input type="checkbox"/>	Service on Structure: <input type="checkbox"/> Navig. Water <input type="checkbox"/> Non-Navig. Water <input type="checkbox"/> Rail <input checked="" type="checkbox"/> Road <input type="checkbox"/> Ped. <input type="checkbox"/> Other
Location description	2.5 km East of Hwy 64	Service under	<input checked="" type="checkbox"/> Navig. Water <input type="checkbox"/> Non-Navig. Water <input type="checkbox"/> Rail <input type="checkbox"/> Road <input type="checkbox"/> Ped. <input type="checkbox"/> Other
Owner/Custodian	Municipality of West Nipissing	Latitude:	46.378097 Longitude: -80.089213
MTO Region	Northern	Heritage Designation:	<input type="checkbox"/> Not Cons. <input type="checkbox"/> Cons./not App. <input type="checkbox"/> List/not Desig <input type="checkbox"/> Desig./notList <input type="checkbox"/> Desig. & List

Field Inspection Information:			
Date of Inspection:	November 09, 2021	Type of Inspection	<input checked="" type="checkbox"/> Reg. OSIM <input type="checkbox"/> Enh

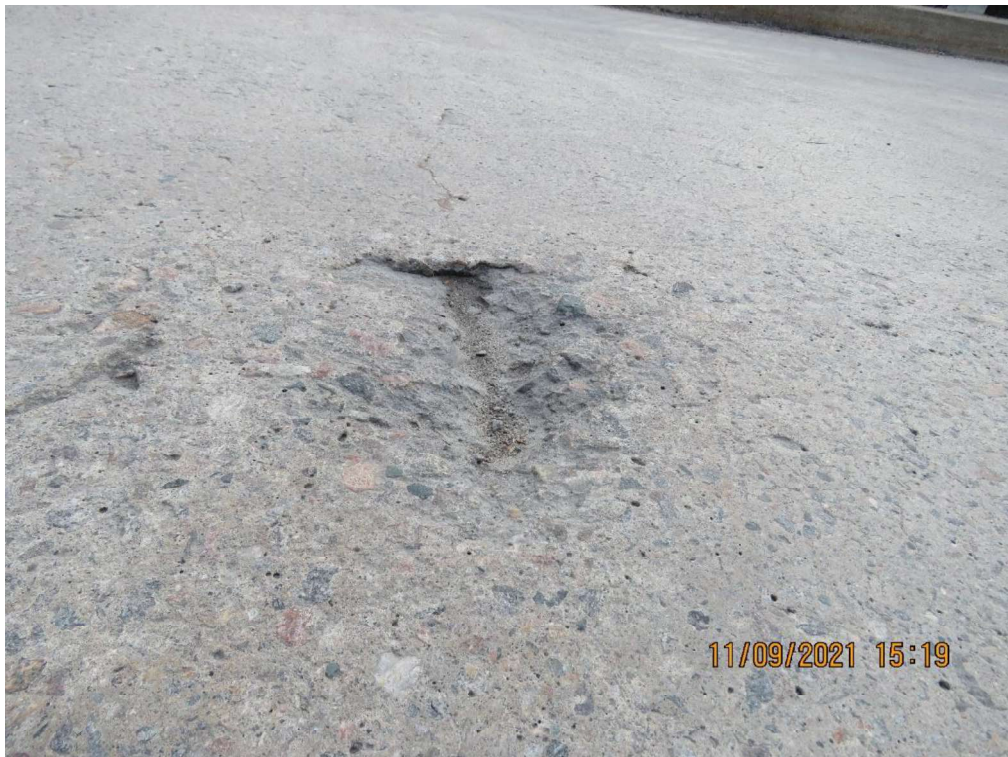
Photo 10: Potholes at Wearing Surface at Structure

Repair deck top				<input type="checkbox"/> Urgent <input type="checkbox"/> 1 year <input type="checkbox"/> 2 year

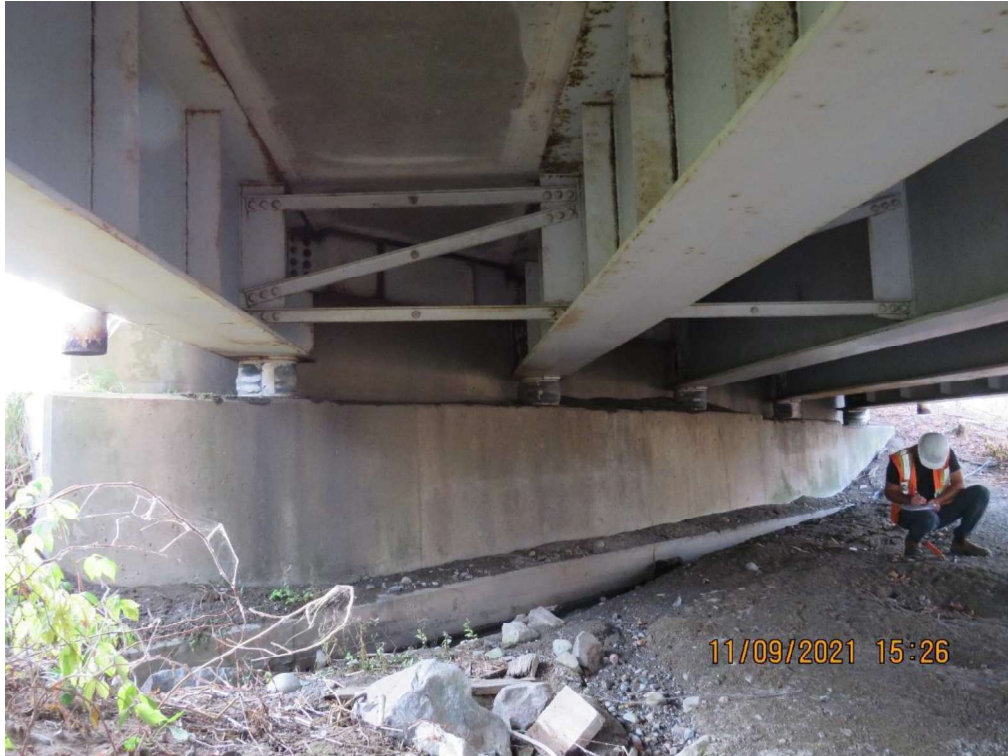
Photo 15: West Abutment

52.8	3	3	00
Comments: Medium cracks. Debris accumulated on bearing seats. Erosion along West abutment's footing.						
Recommended Work:			Maintenance Needs: 02			
<input checked="" type="checkbox"/> Rehab <input type="checkbox"/> Replace <input type="checkbox"/> 1-5 years <input checked="" type="checkbox"/> 6-10 years			<input type="checkbox"/> Urgent <input checked="" type="checkbox"/> 1 year <input type="checkbox"/> 2 year			
			Clean bearing seats

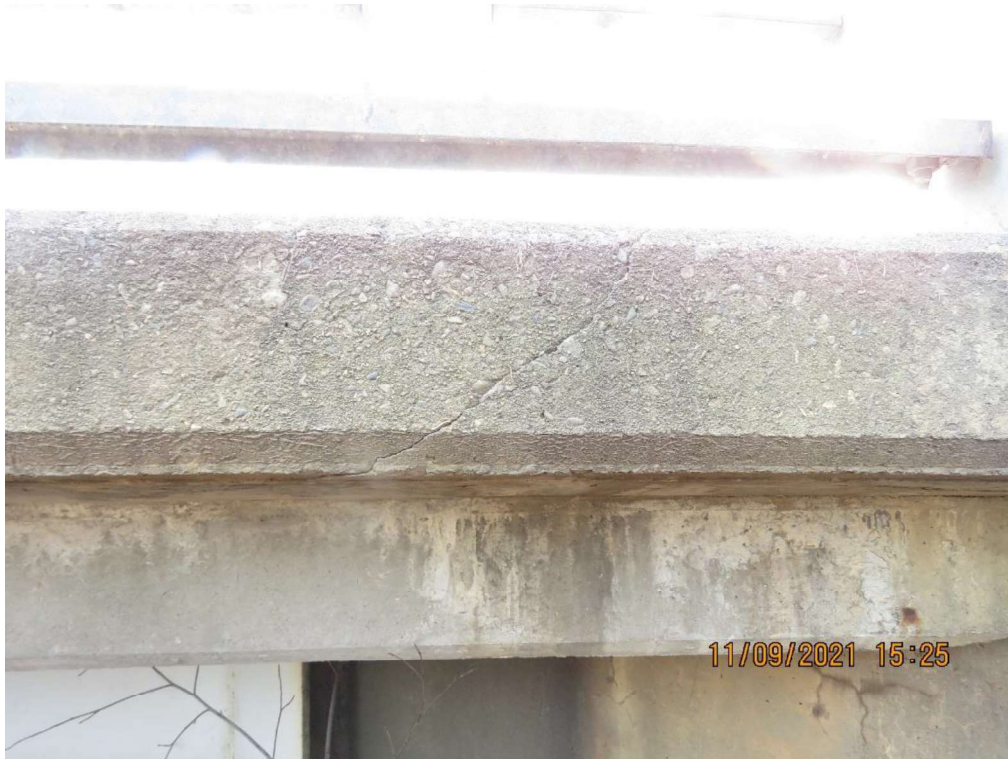
Photo 21: Crack at NW Fascia

Repair concrete at slab fascia				<input type="checkbox"/> Urgent <input type="checkbox"/> 1 year <input type="checkbox"/> 2 year

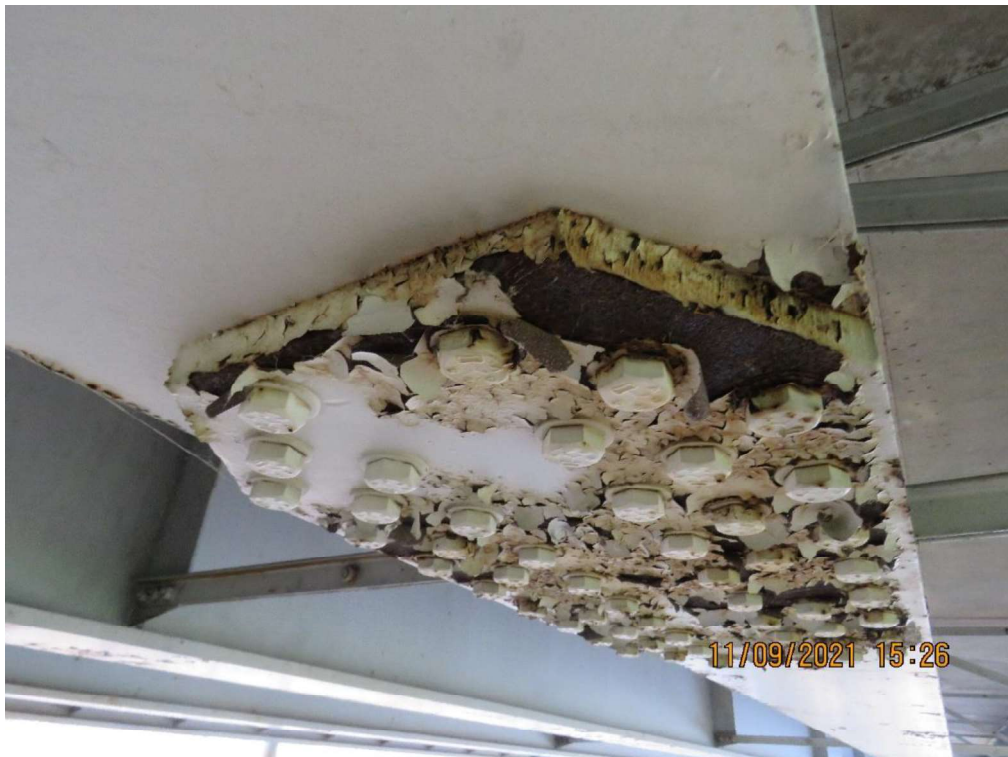
Photo 22: Coating Peeling Off at Bottom of Girders Bolted Connection

Coat girder ends				<input type="checkbox"/> Urgent <input type="checkbox"/> 1 year <input type="checkbox"/> 2 year

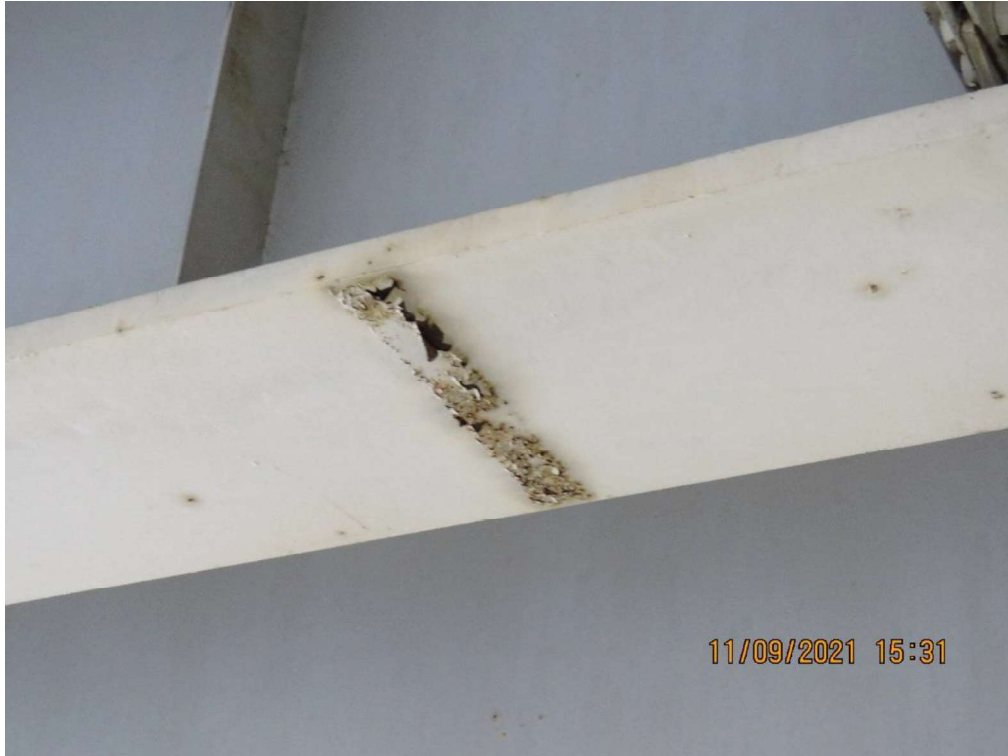
Photo 23: Coating Peeling Off at Bottom of Girders

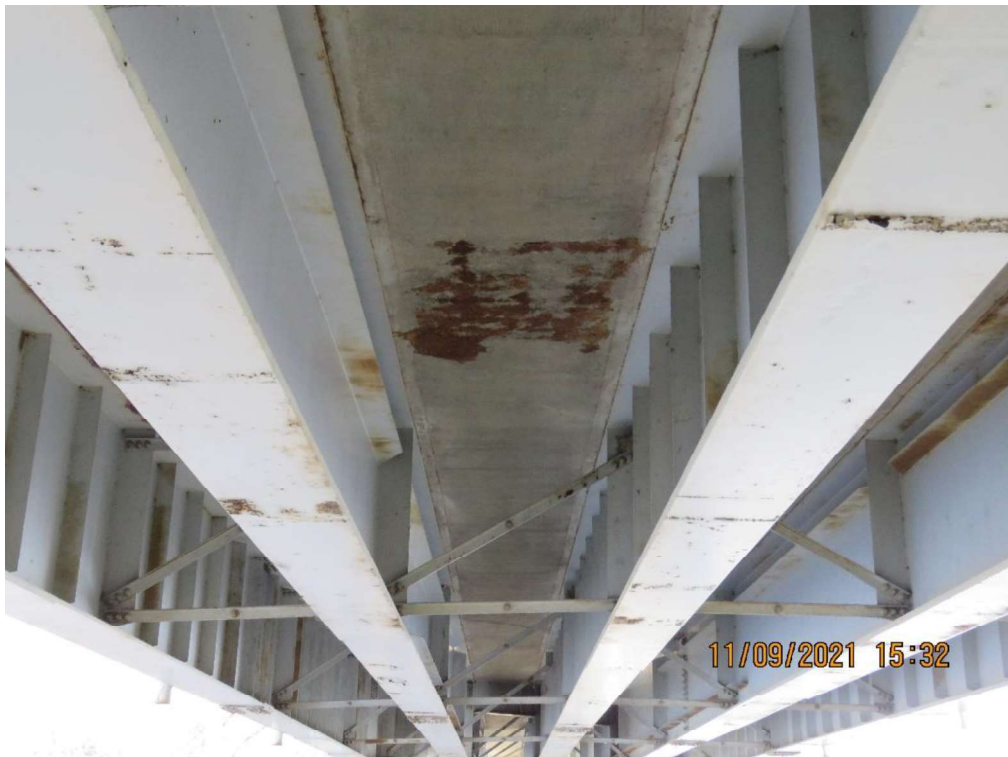
Photo 24: Rust Stains at midspan of Soffit

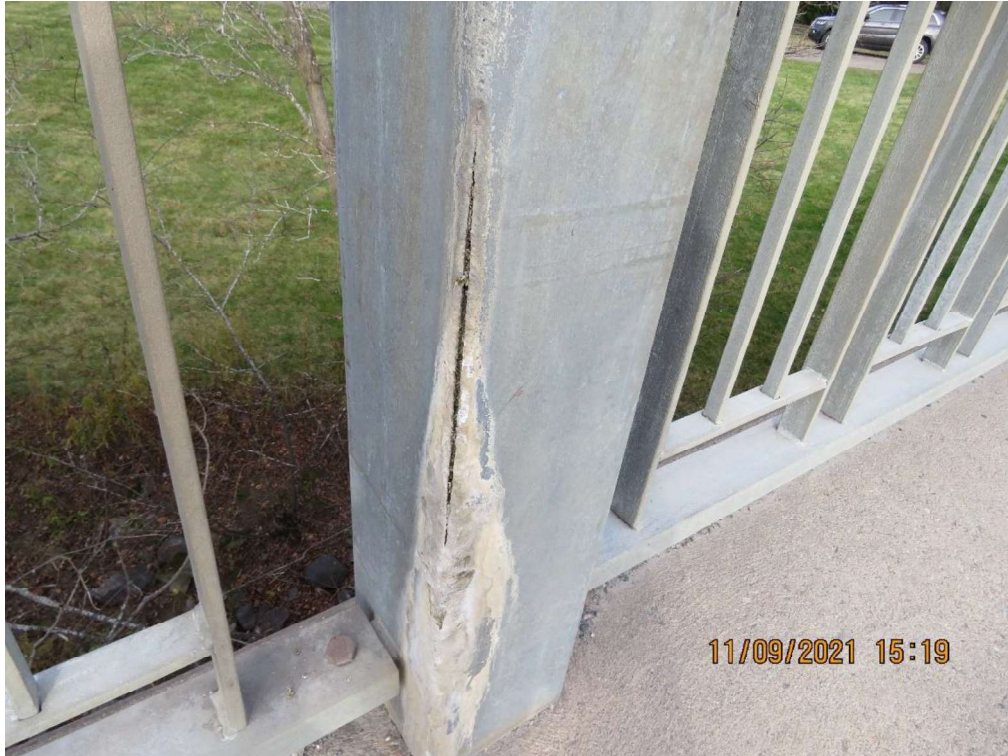
Photo 25: Split at North Rail Post

<input checked="" type="checkbox"/> Urgent <input type="checkbox"/> 1 year <input type="checkbox"/> 2 year		
				Repair post/deck connection. Replace missing post caps. Repair out of alignment railing posts

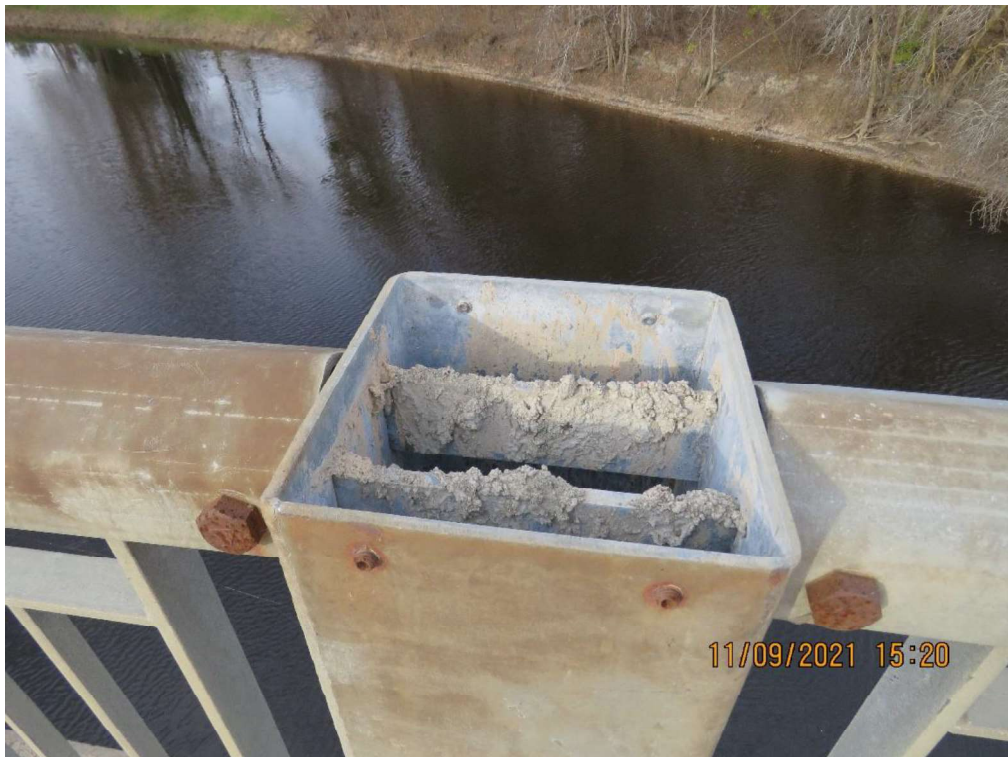
Photo 26: Missing Post Cap at Several Posts

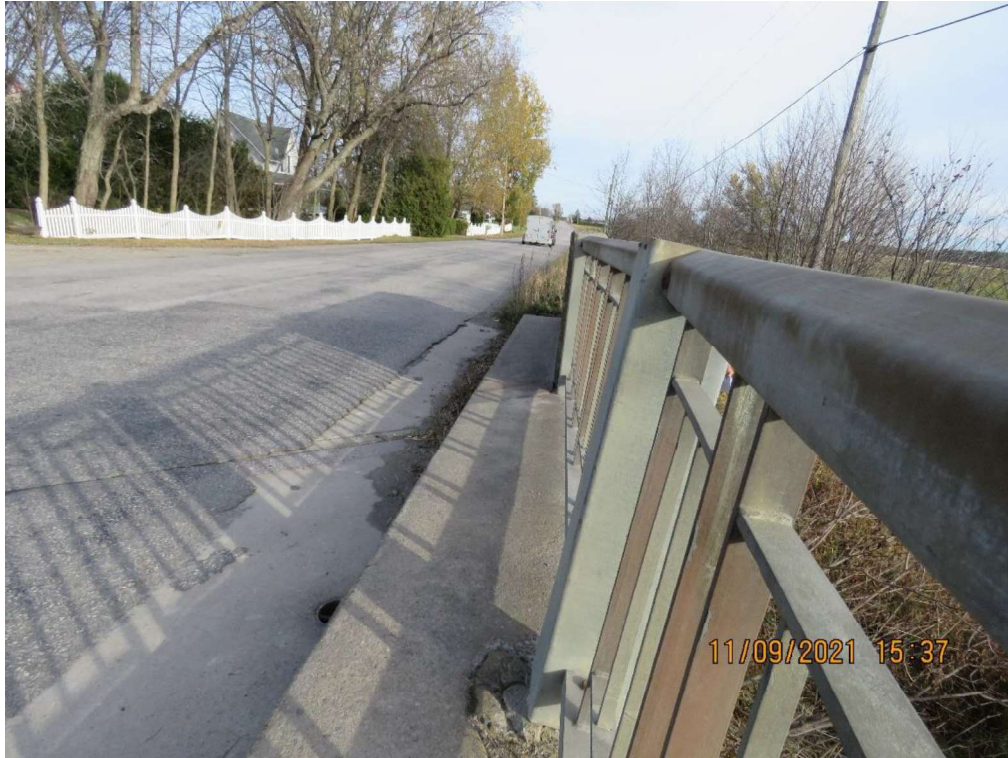
Photo 27: Deflected Post at SE Quadrant
