Ontario Structure Inspection Manual – Inspection Form

Structure Name	Labrosse Road Culvert		
Main Highway #	N/A	On <input type="checkbox"/> Under <input type="checkbox"/>	Service on Structure: <input type="checkbox"/> Navig. Water <input type="checkbox"/> Non-Navig. Water <input type="checkbox"/> Rail <input checked="" type="checkbox"/> Road <input type="checkbox"/> Ped. <input type="checkbox"/> Other
Location description	Labrosse Road, 2.1 km East of Hwy 575 at Cache River	Service under <input type="checkbox"/> Navig. Water <input checked="" type="checkbox"/> Non-Navig. Water <input type="checkbox"/> Rail <input type="checkbox"/> Road <input type="checkbox"/> Ped. <input type="checkbox"/> Other	
Owner/Custodian	Municipality of West Nipissing	Latitude: 46.450413	Longitude: -80.095898
MTO Region	Northern	Heritage Designation: <input checked="" type="checkbox"/> Not Cons. <input type="checkbox"/> Cons./not App. <input type="checkbox"/> List/not Desig <input type="checkbox"/> Desig./notList <input type="checkbox"/> Desig. & List

Field Inspection Information:			
Date of Inspection:	November 10, 2021	Type of Inspection	<input checked="" type="checkbox"/> Reg. OSIM <input type="checkbo

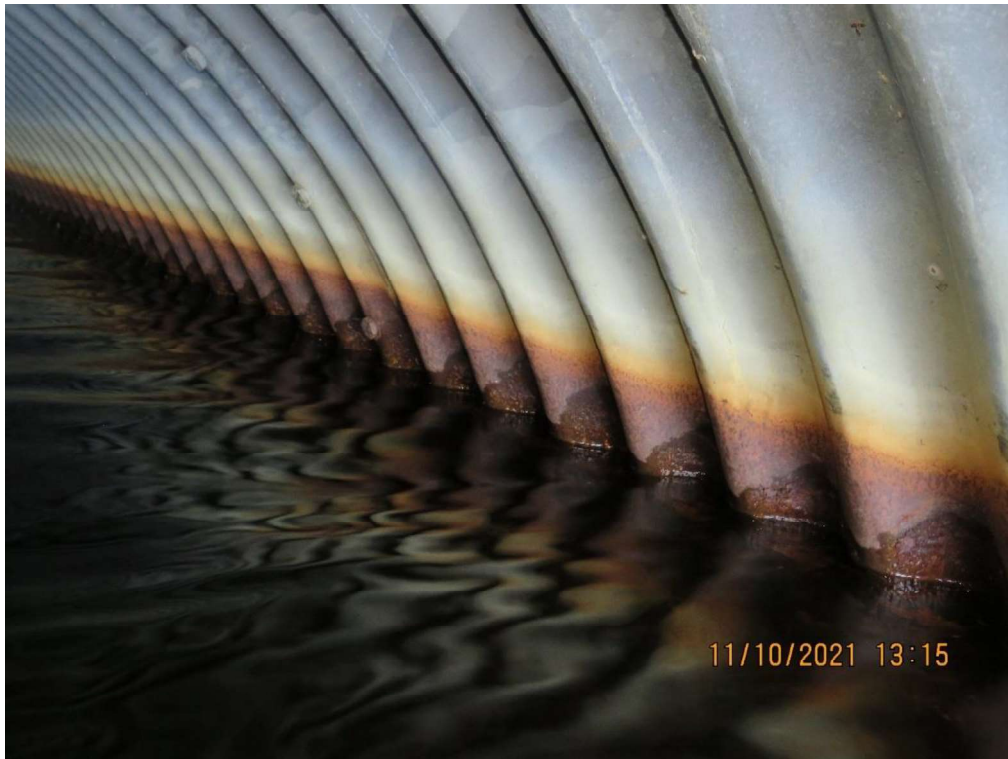
Photo 9: East Wall Corrosion at Waterline

Paint barrel at water line				<input type="checkbox"/> Urgent <input type="checkbox"/> 1 year <input type="checkbox"/> 2 year

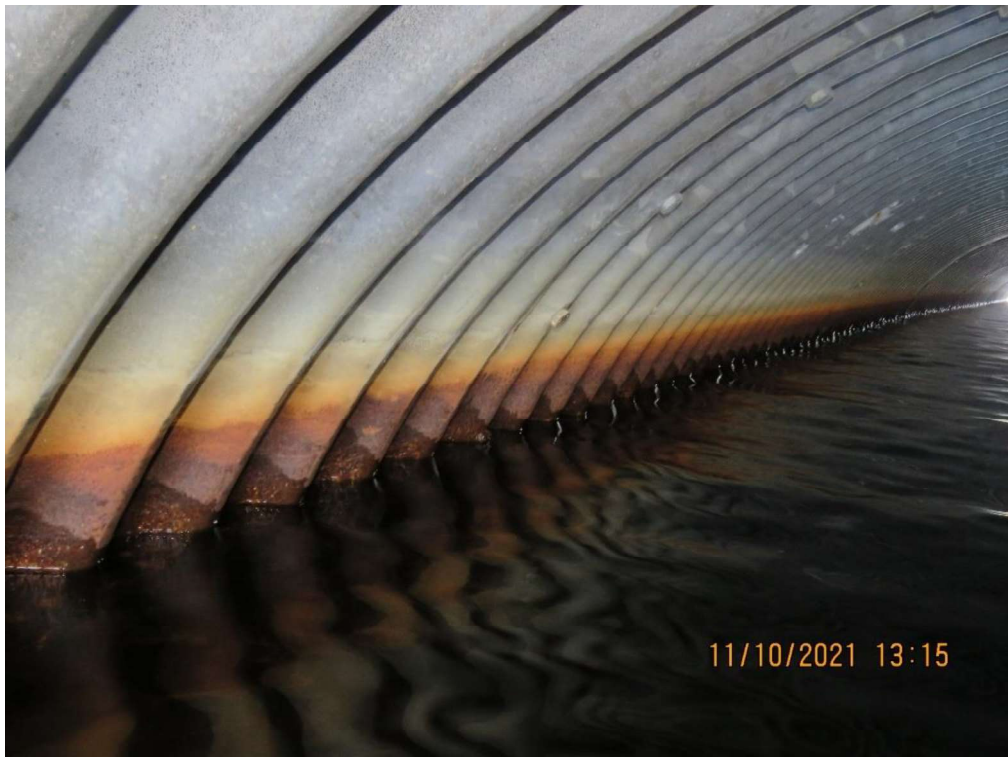
Photo 10: West Wall Corrosion at Waterline
