Structure Name	Levac Road Culvert No. 2		
Main Hwy/Road #	<input type="text"/>	On <input type="checkbox"/>	Under <input type="checkbox"/>
	Crossing <input type="checkbox"/> Navig. Water <input checked="" type="checkbox"/> Non-Navig. Water <input type="checkbox"/> Rail Type: <input checked="" type="checkbox"/> Road <input type="checkbox"/> Ped. <input type="checkbox"/> Other		
Hwy/Road Name	Levac Road		
Structure Location	0.65 km west of Arcand Road		
Latitude	46.379147	Longitude	-80.00738
Owner(s)	Municipality of West Nipissing	Heritage	<input type="checkbox"/> Not Cons. <input type="checkbox"/> Cons./not App. <input type="checkbox"/> List/not Desig.
MTO Region	Northeastern	Designation:	<input type="checkbox"/> Desig./not List <input type="checkbox"/> Desig. & List
MTO District	Sudbury	Road Class:	Freeway <input type="checkbox"/> Arterial <input type="checkbox"/> Collector <input type="checkbox"/> Local <input checked="" type="checkbox"/>

Old County		Posted Speed	<input type="text"/>
Geographic Twp.	Caldwell	No. of Lanes	2
Structure Type	Arch Culvert	AADT	<input type="text"/>
Total Deck Length	N/A	% Trucks	<input type="text"/>
Overall Str. Width	19.15	Inspection Route Sequence	<in

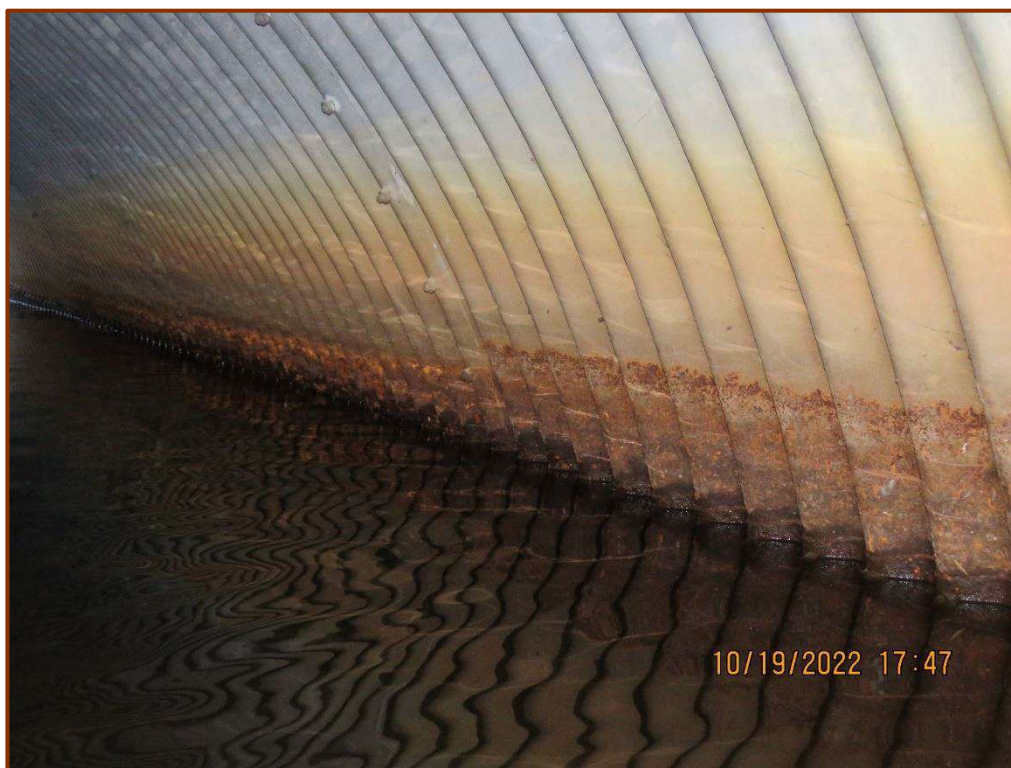
5. C-109 2022-10-19 Medium Corrosion at Waterline (typical)
