## **ADDENDUM NO. 1**

Re: Sturctural Repairs 2026-015

STRUCTURE INSPECTION REPORT

ASHBURN ROAD BRIDGE

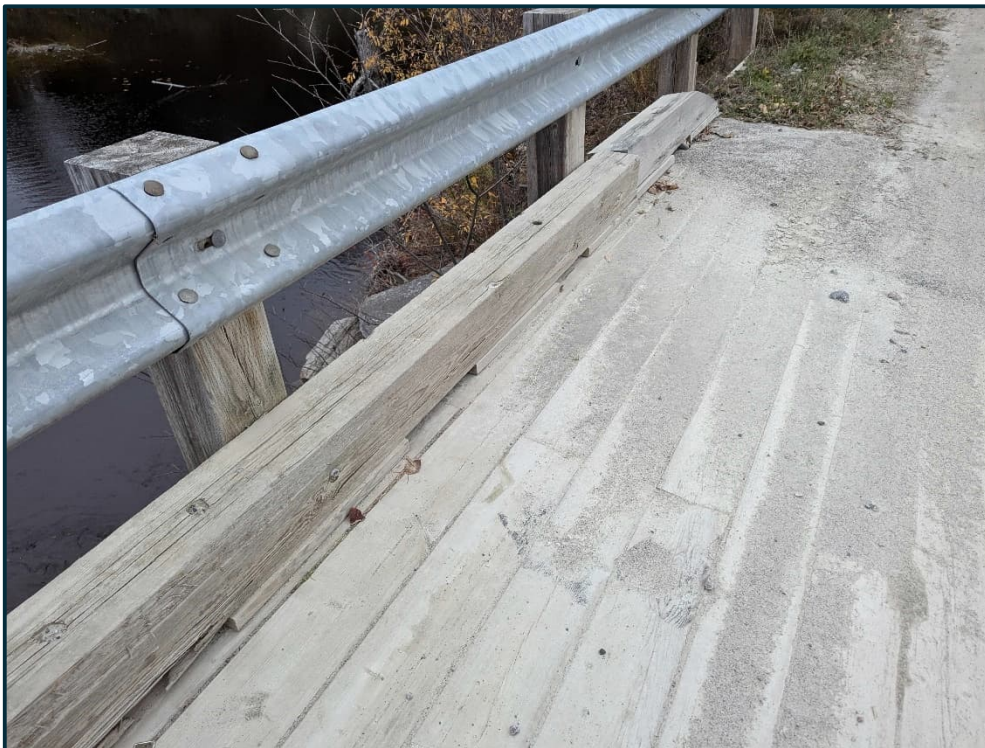
6. B-030 2024-10-23 Abrasions in Curb

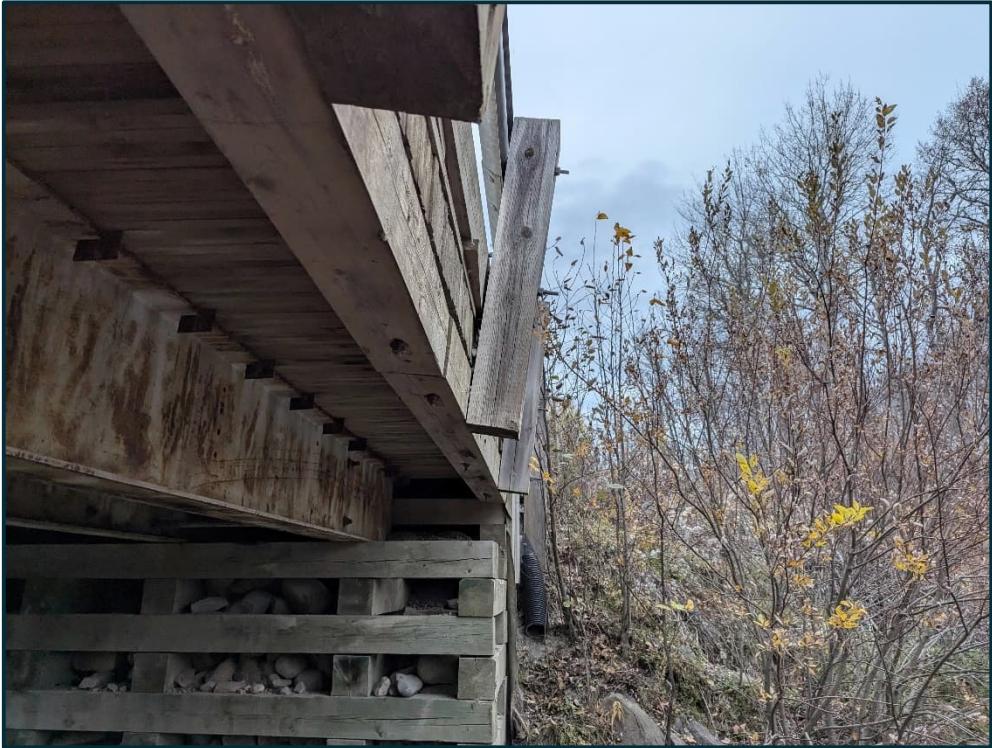
8. B-030 2024-10-23 Barrier Post Leaning

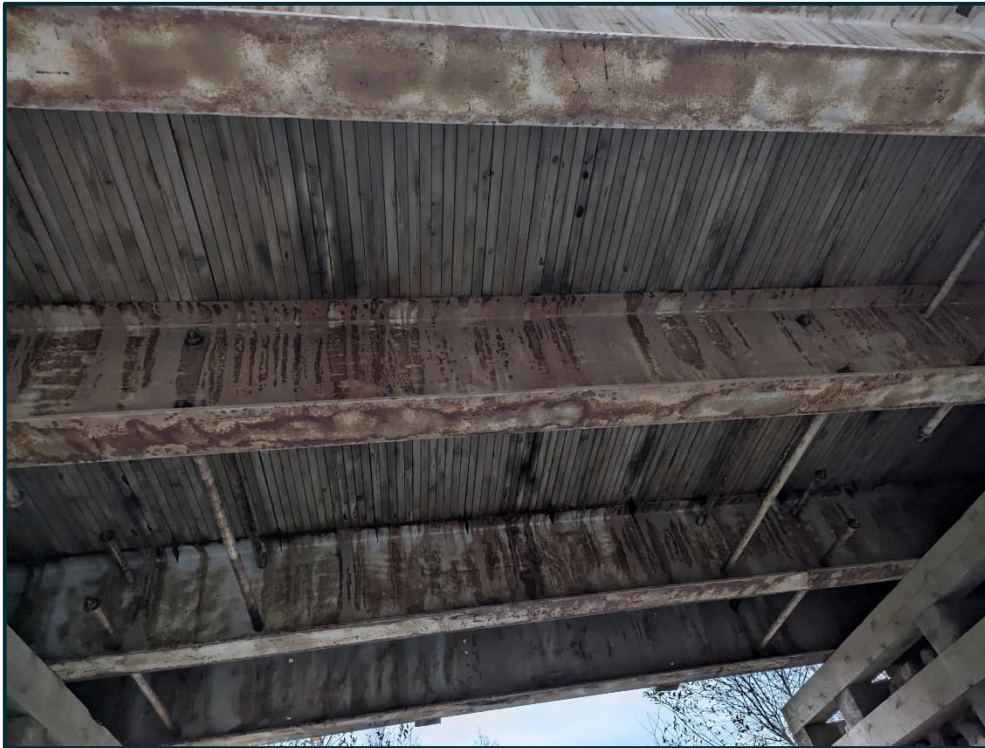
<b>Structure Name: Ashburn Road Bridge</b>	
Comments: Corrosion along entire length of girders. Beaver dam upstream at abutment.	
Overall Condition Rating	Good
Bridge Condition Index (BCI)	73.5

9. B-030 2024-10-23 Girders and Soffit Typical

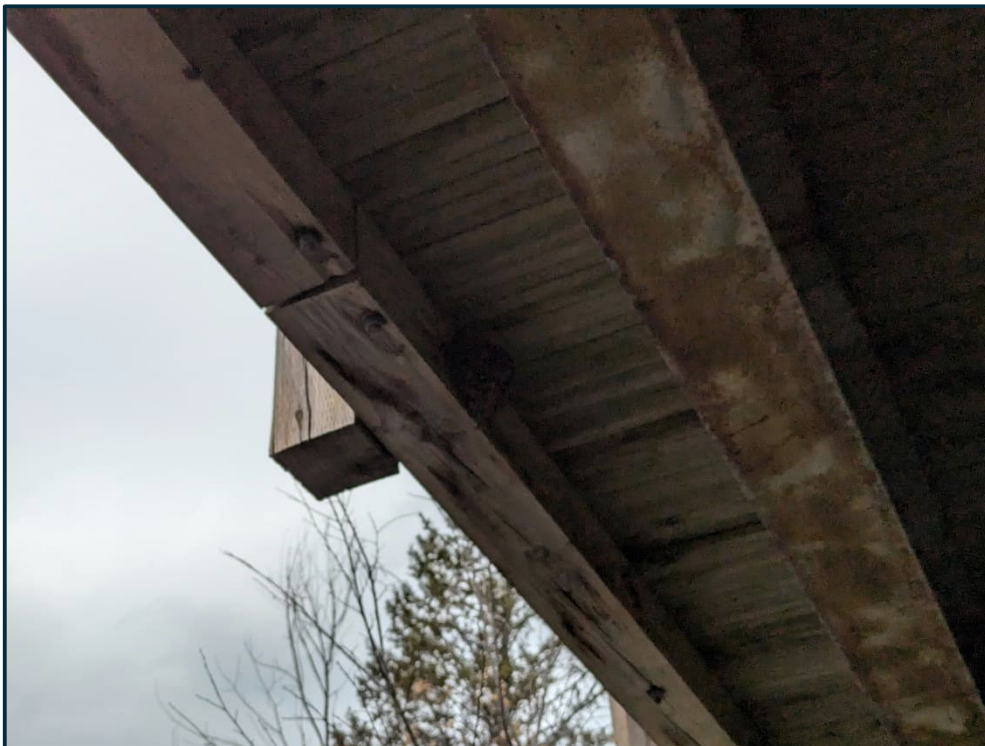
10. B-030 2024-10-23 Birds Nest on Structure

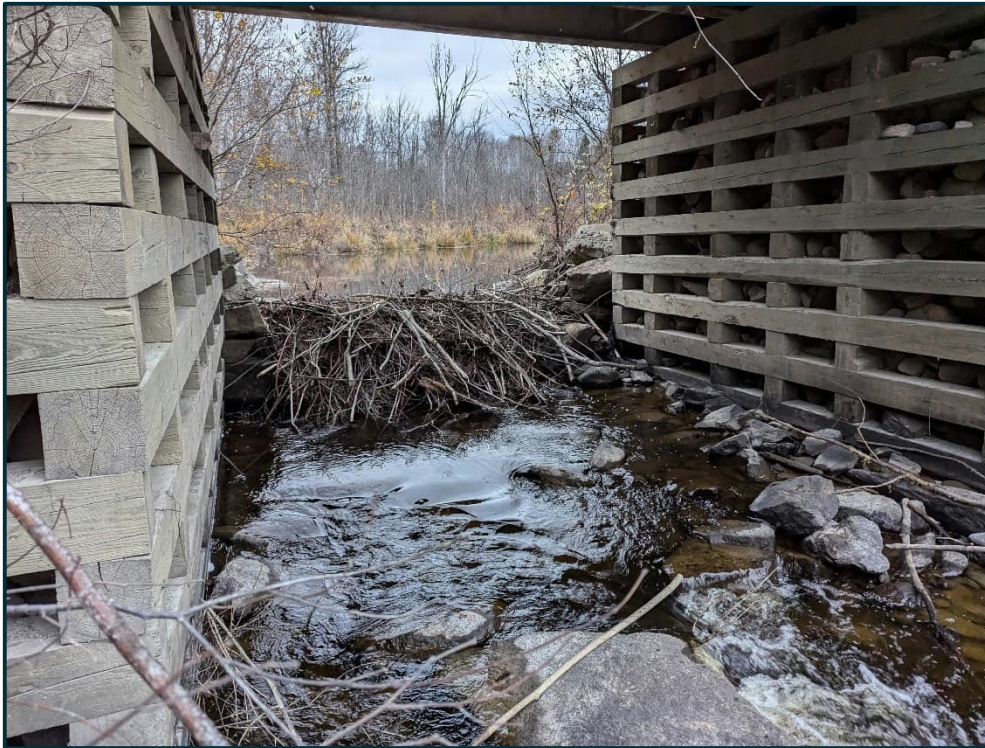
19. B-030 2024-10-23 Bever Dam Below Structure

Element Group:	Embankments & Streams			Length:	
Element Name:	<b>Streams and Waterways</b>			Width:	
Location:				Height:	
Material:				Count:	1
Element Type:				Total Quantity:	1
Environment:	<b>Benign</b> / Moderate / Severe			Limited Inspection	<input type="checkbox"/>
Protection System:					Perform. Deficiencies
<b>Condition Data:</b>	Units m <sup>2</sup> / m / <b>each</b> / % / all	Exc.	Good	Fair	Poor
					1
<b>Comments:</b> Beaver dam upstream at abutment.					
<b>Recommended Work:</b>	<input type="checkbox"/> Rehab <input type="checkbox"/> Replace <input type="checkbox"/> 1-5 years <input type="checkbox"/> 6-10 years		<b>Maintenance Needs:</b>	11	
			<input type="checkbox"/> Urgent <input checked="" type="checkbox"/> 1 year <input type="checkbox"/> 2 year Remove beaver dam
