# Appendix to support written submission for ZBLA2021/04 - Proposed Zoning By-Law Amendment at Villeneuve Court

By Pierre Leblanc,  
on behalf of H  l  ne Leblanc  
120 Bay ST.

Planning Advisory Committee Meeting  
March 8, 2021

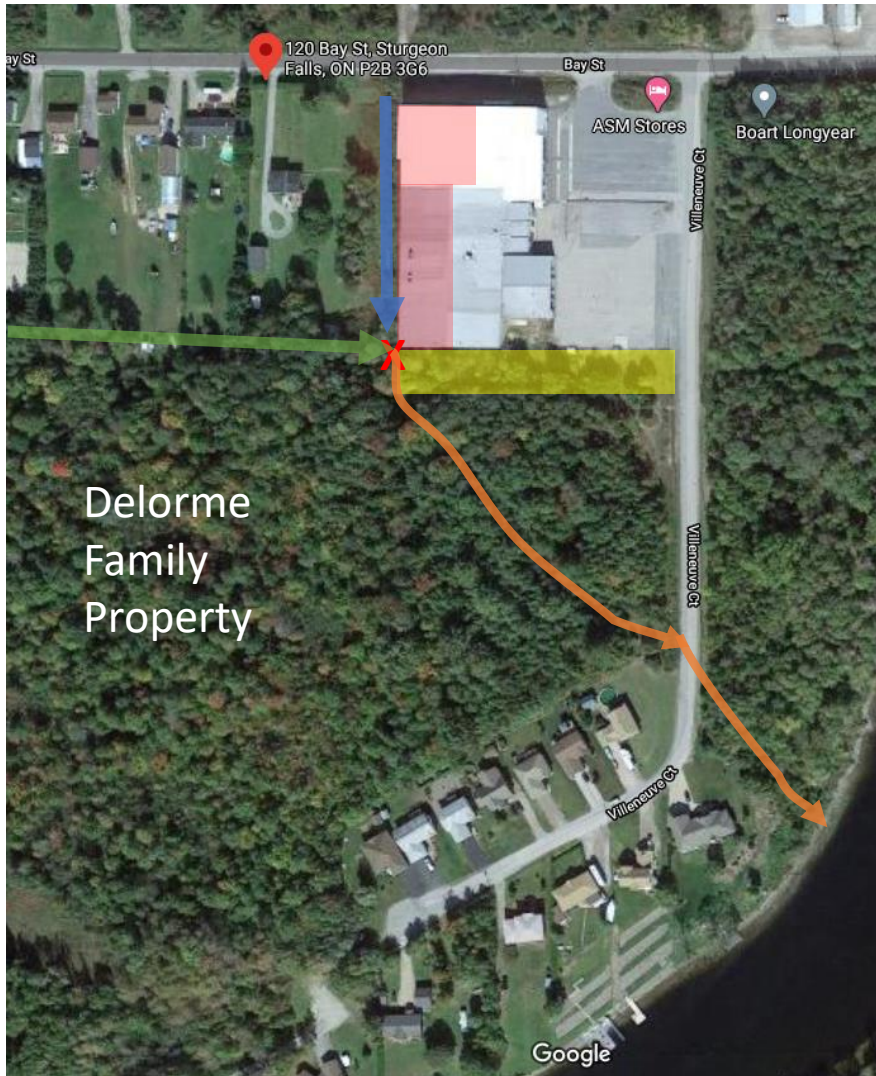
- The orange arrows in both images represents the approximate path of the south/east drainage ditch that flows water to the Sturgeon River.
- This drainage is blocked at the red “X”.
- A drainage plan for adjoining properties 106 Bay ST and proposed lot should have a drainage as effective as historic drainage system in place for over 40 years.

Google Satellite image was taken before development at south end of 106 Bay ST. **Slide 7** provides a current view of this portion of the property.

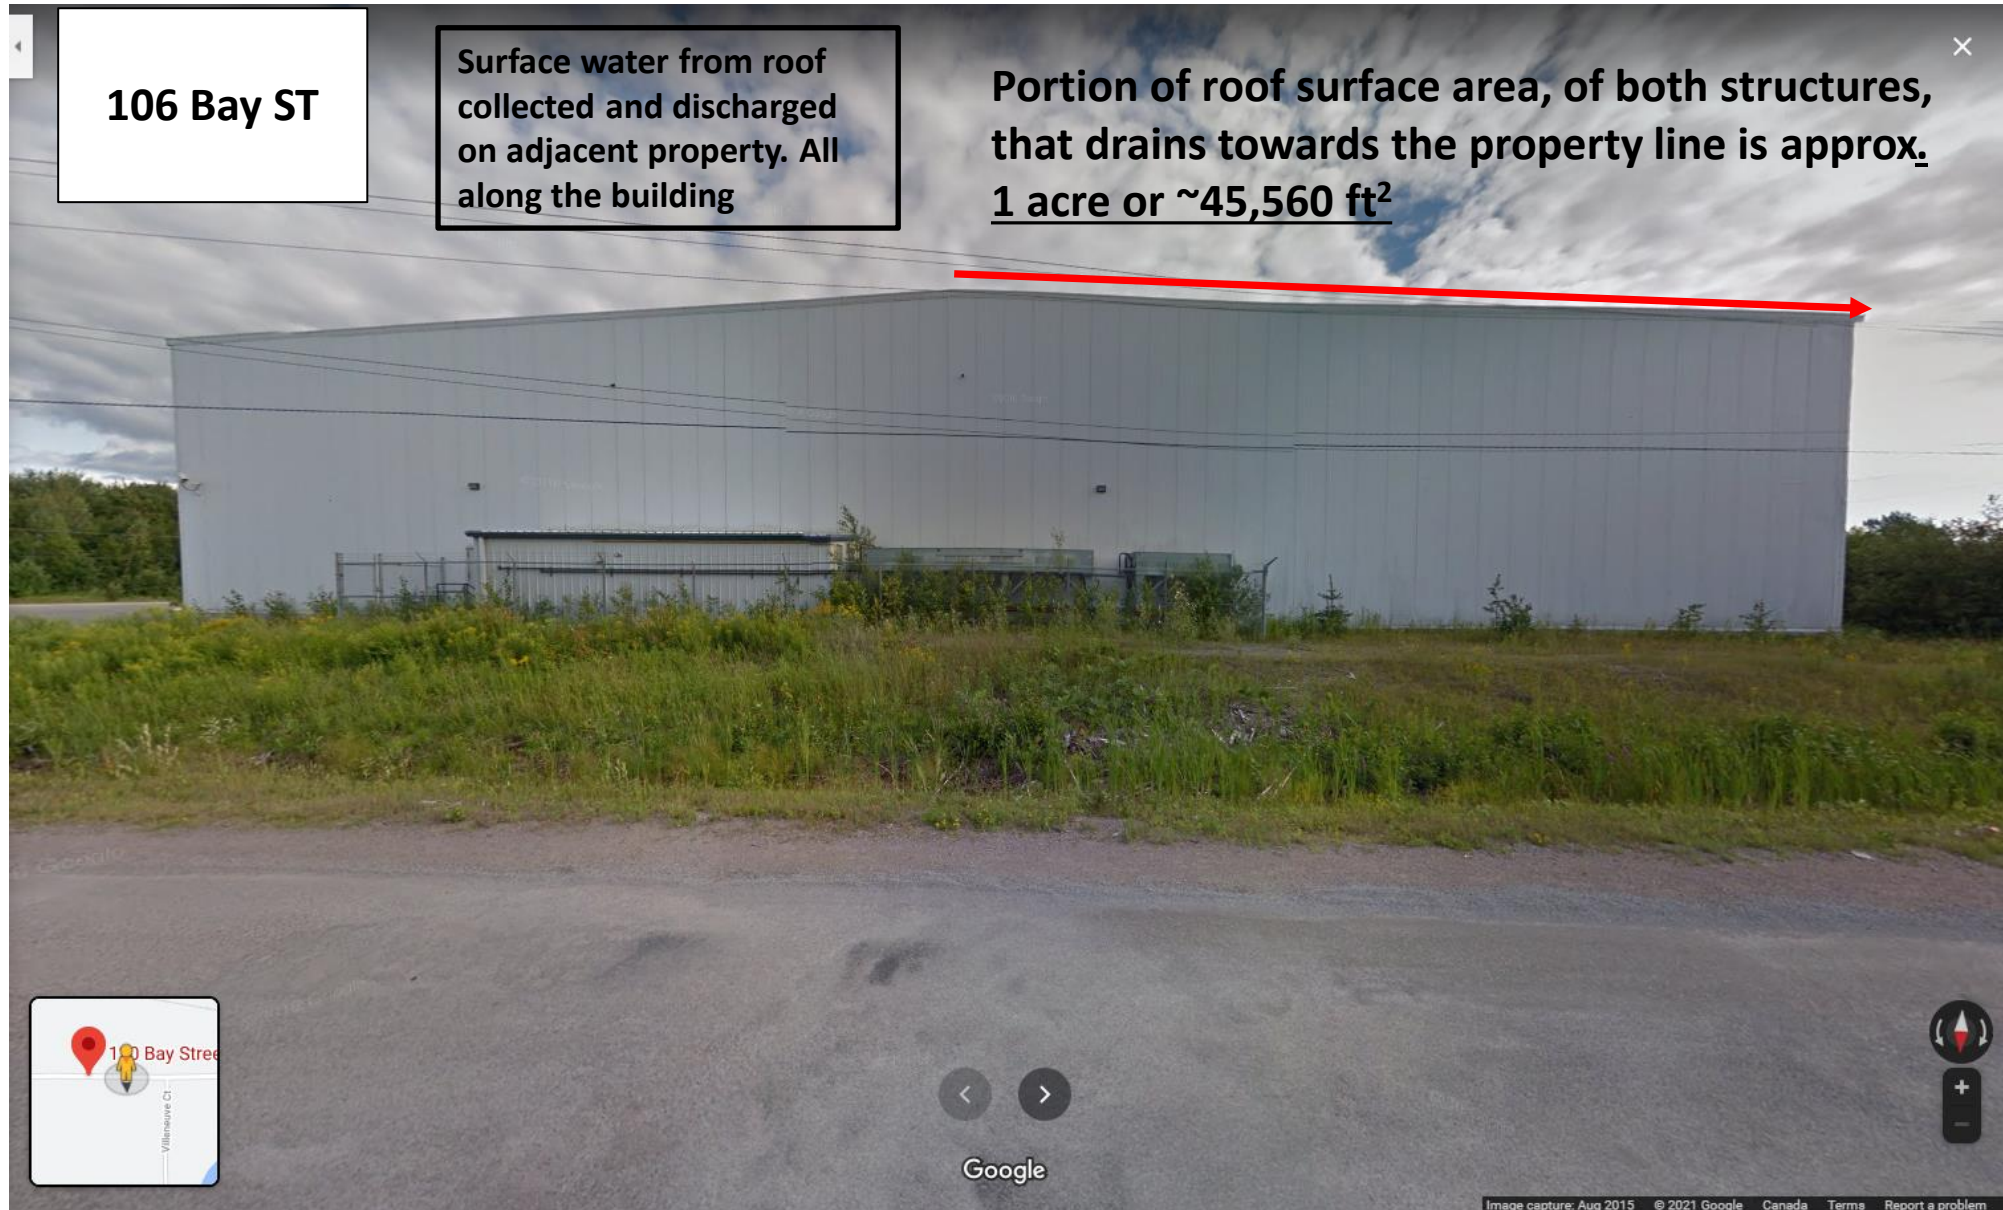
Photo Taken on June 6, 2020

- Owners of 106 Bay ST have back filled their portion of the drainage ditch on property line. They are essentially draining their surface water 120 Bay ST.
- Portion of roof surface area, of both structures, that drains towards the property line is ~1 acre or ~45,560 ft<sup>2</sup>
- By-Law 2001/71 - Property Standards – West Nipissing
  - 3.3 Sewage and Drainage - 3.3.3 **No roof drainage or sump pump shall be discharged on sidewalks or stairs of the premises or neighbouring property.**
- Ontario – Ministry of Agriculture, Food and Rural Affairs
  - Property owners that collect surface water (e.g. roof or downspouts) have an obligation to discharge that water where it will not cause problems to downstream property owners.

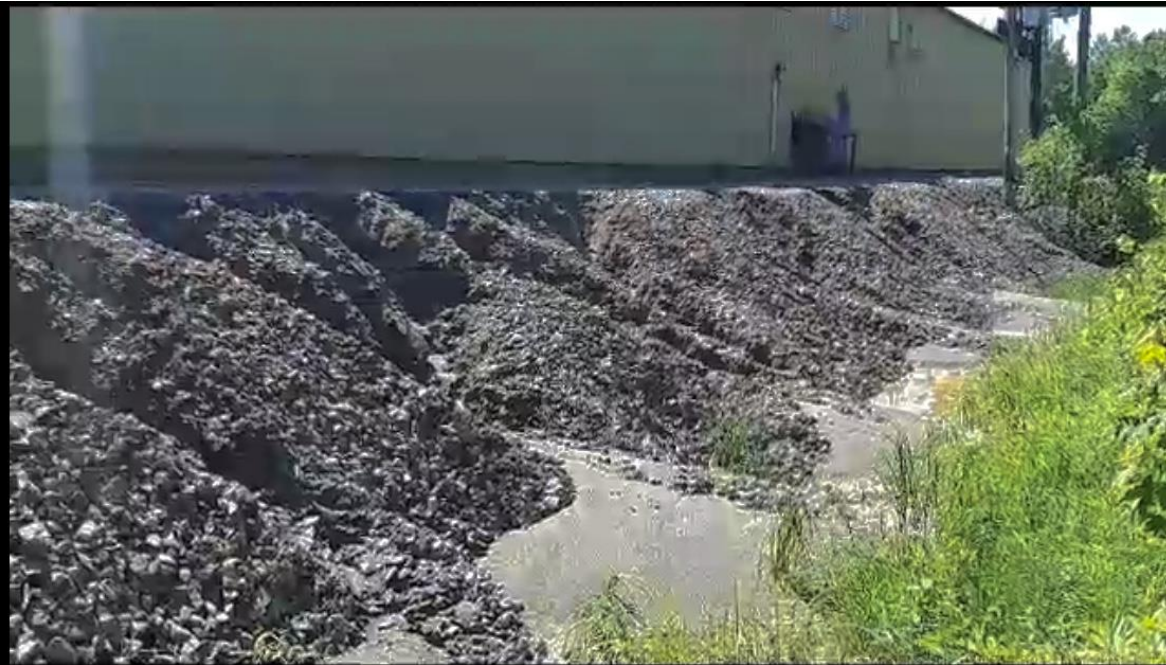
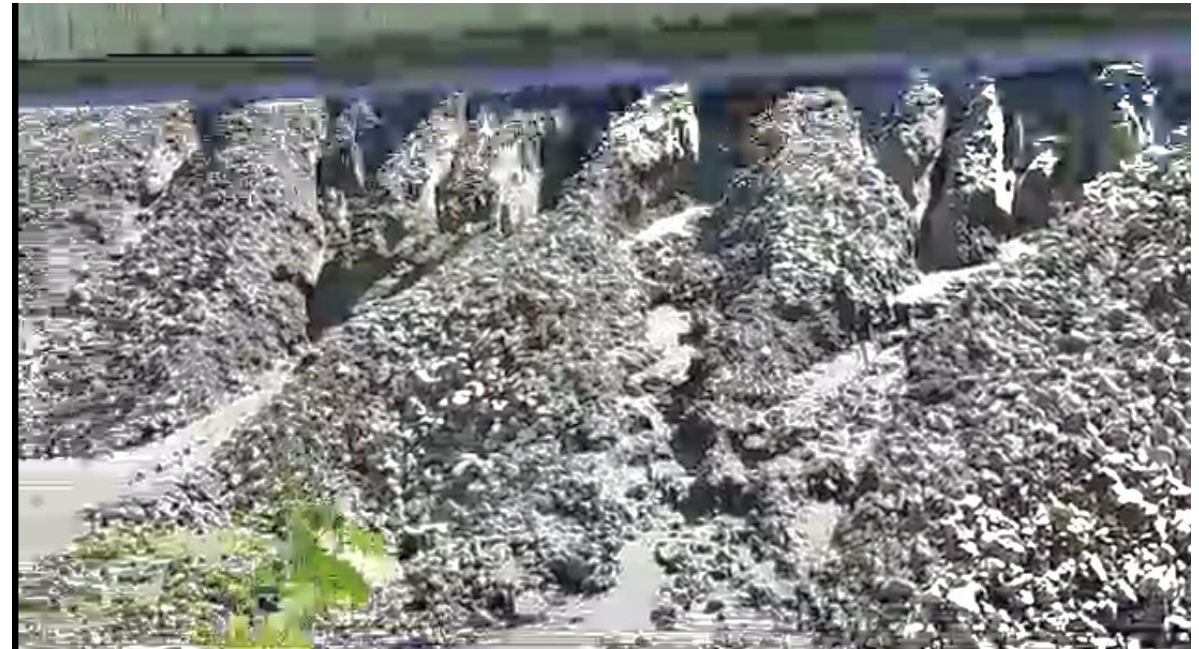
Photos were taken on June 28, 2020 after a single storm.

- Impact of one single storm demonstrates the significant quantity of collected surface water being discharged from the large roof surface area towards neighbouring property at 120 Bay ST.
- Older building with no downspouts.
- Slide 5 depicts condition of slope in photo taken earlier the same month.

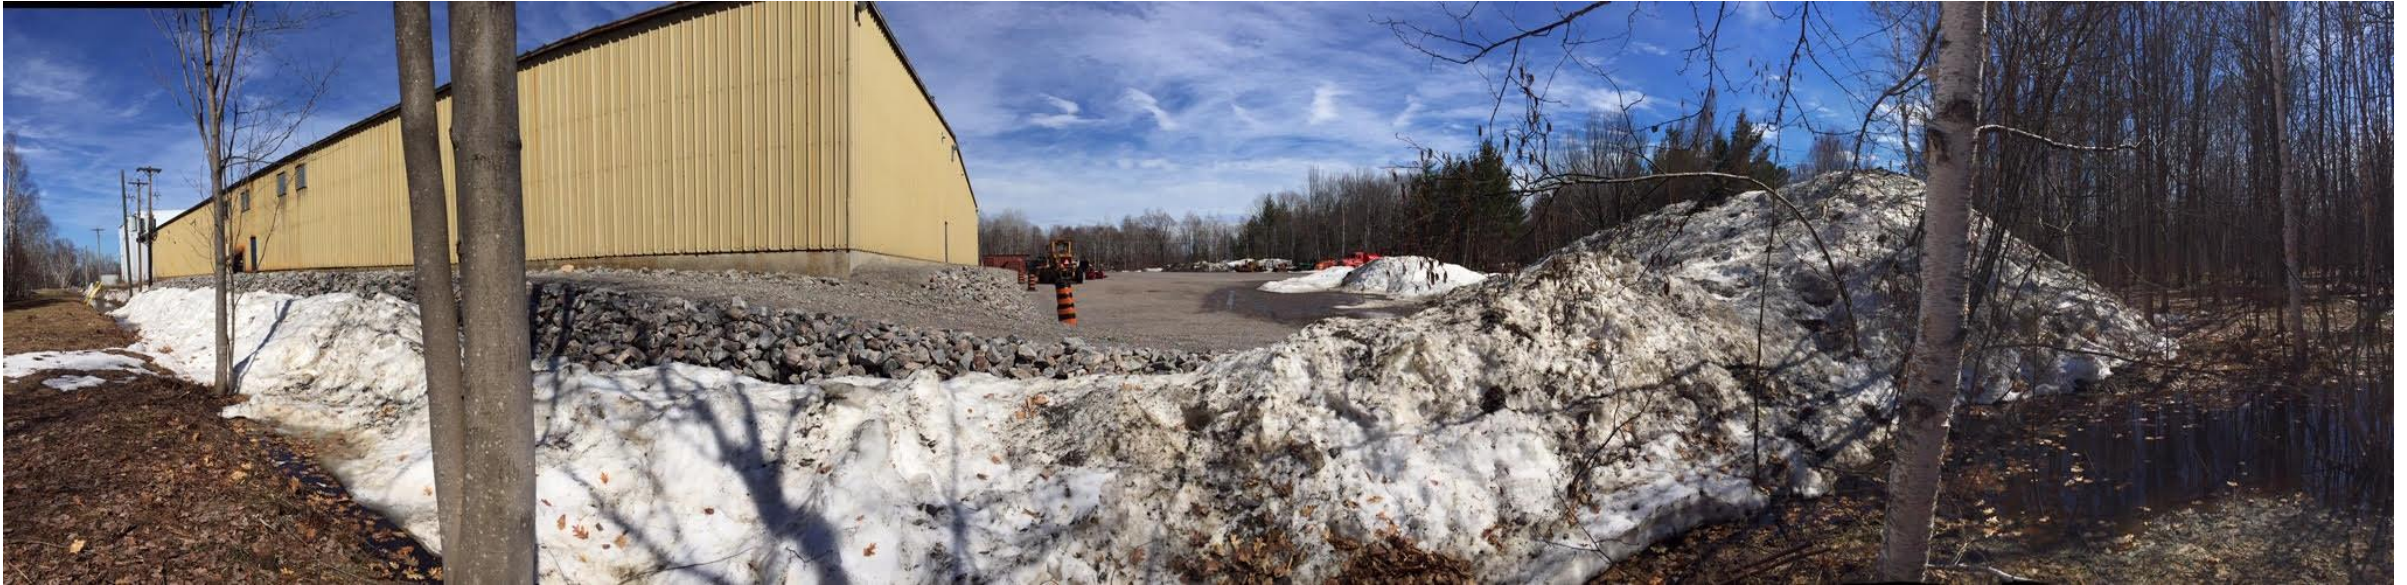
Photo taken in April 2019

South end of 106 Bay ST as described on [slide 3](#) – area highlighted in yellow. Satellite photo on slide taken before property owners raise the elevation of this portion of their land.

Development at south end of 106 Bay ST blocks traditional southeast drainage ditch (see slides 2 and 3). This blockage causes surface water, mainly from 106 Bay ST, to accumulate on the south end property of 120 Bay ST and Delorme family property.

Yellow lines represent the property lines.

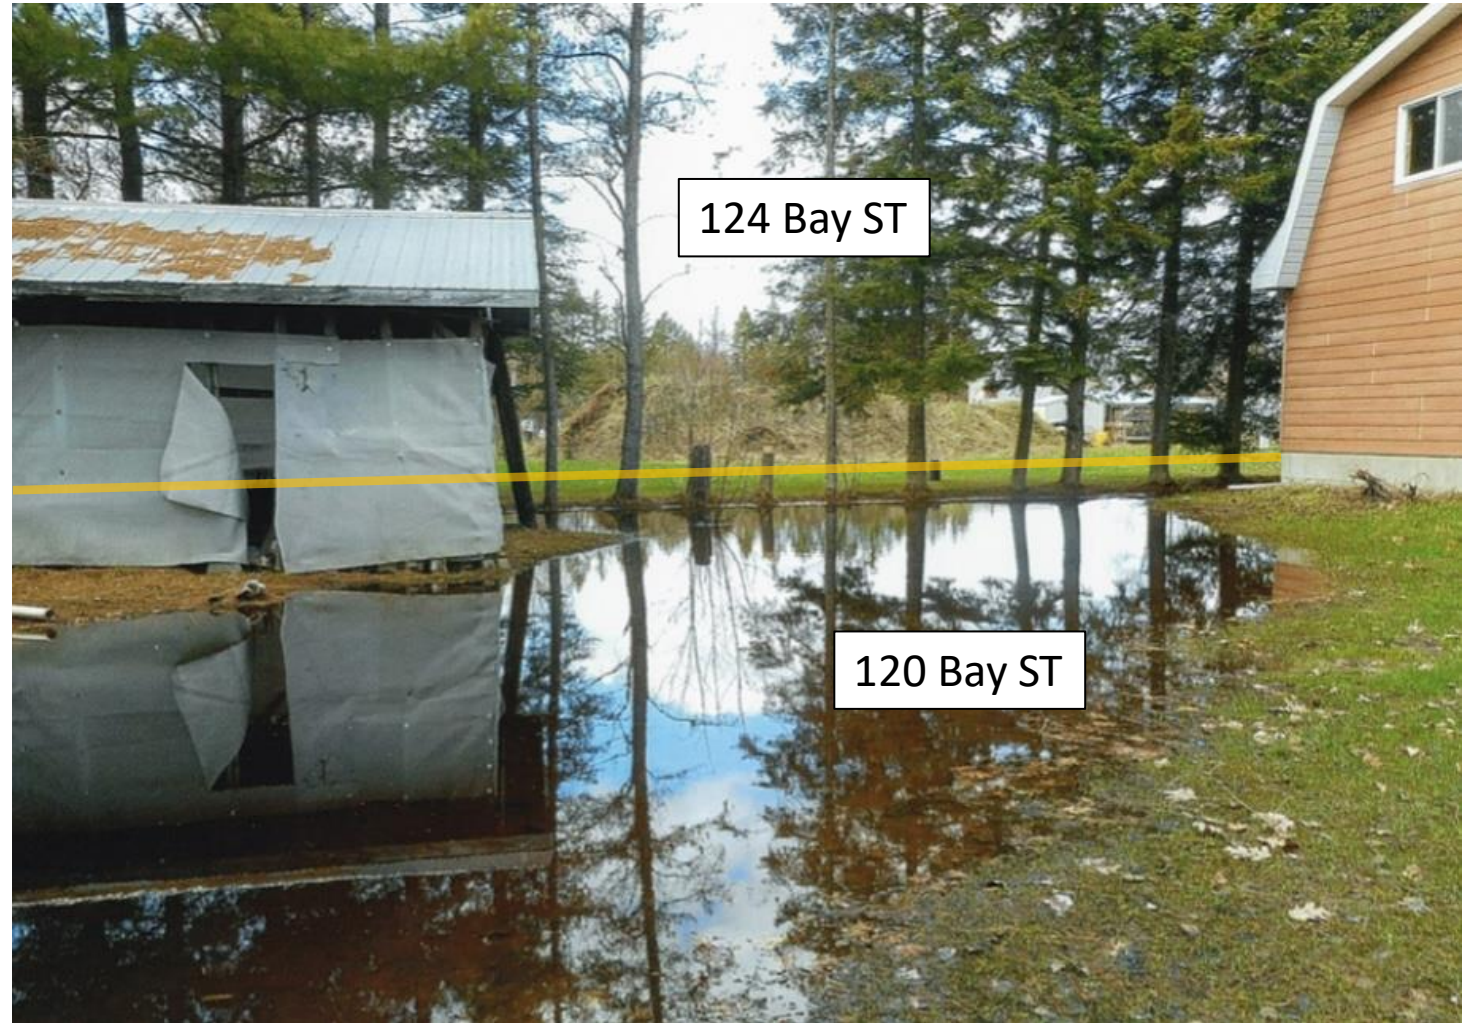
Photo taken in fall 2020

South end of 120 Bay ST and  
neighbouring property 124 Bay  
ST

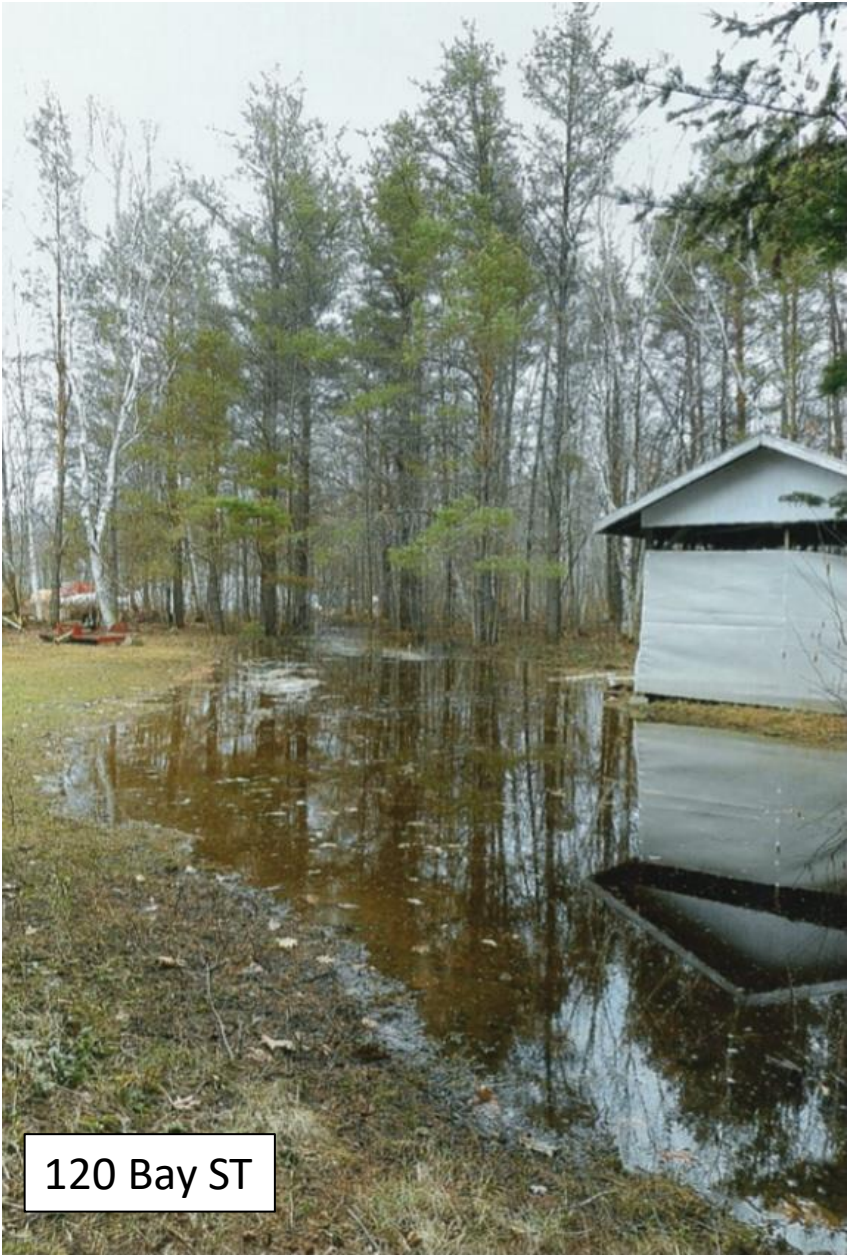
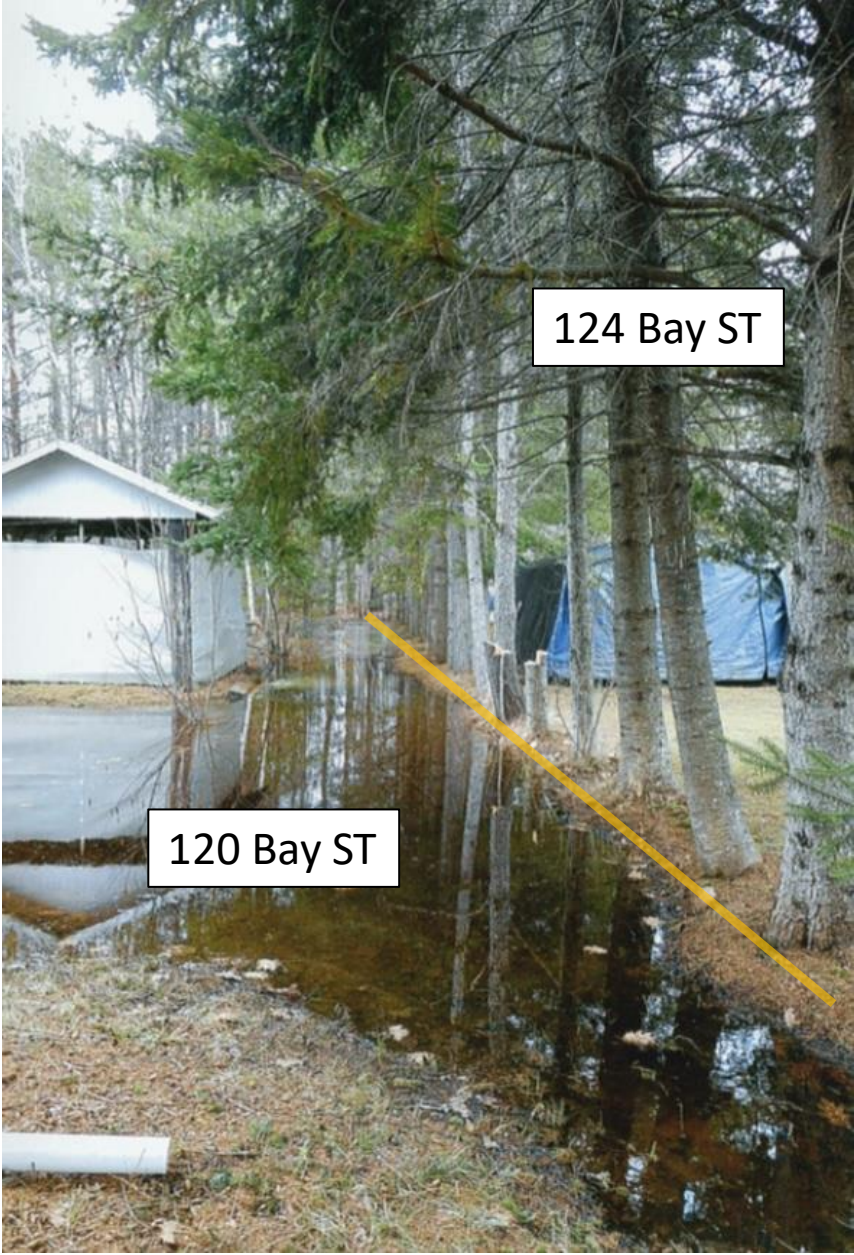
Photos taken at various times in spring 2020
