## **ADDENDUM NO. 1**

Re: Sturctural Repairs 2026-015

STRUCTURE INSPECTION REPORT

ASHBURN ROAD BRIDGE

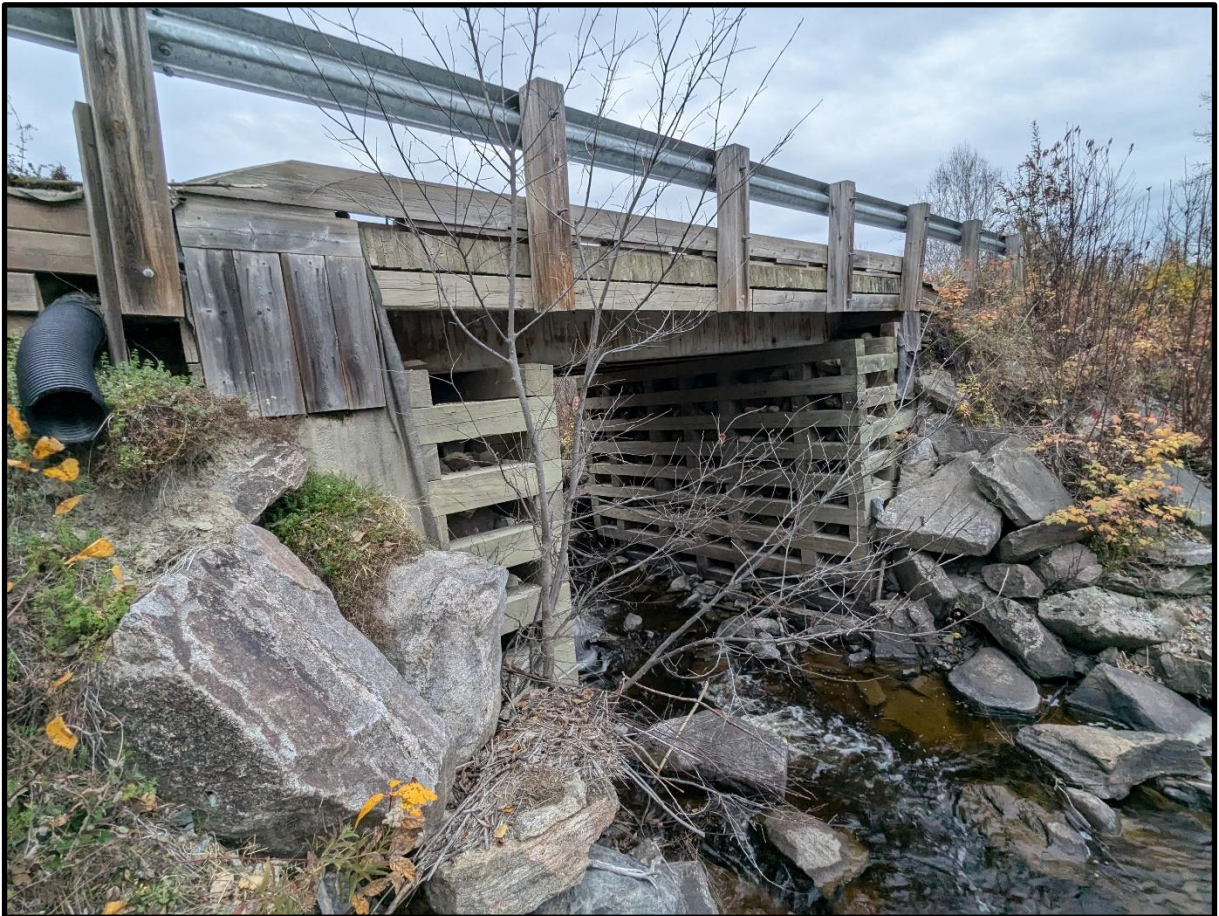
<b>Structure Name: Ashburn Road Bridge</b>	
Comments: Corrosion along entire length of girders. Beaver dam upstream at abutment.	
Overall Condition Rating	Good
Bridge Condition Index (BCI)	73.5
