## EXECUTIVE SUMMARY

The Municipality of West Nipissing has undertaken the development of an Asset Management Plan in response to the Ontario Government's provincial capital funding requirements. The purpose of this Asset Management Plan is to assist with prioritizing needs over wants to ensure that infrastructure funding, whether generated through local or senior levels of government, be applied to projects with a greater priority. This Asset Management Plan has been structured to adhere to the requirement described in the Ontario Ministry of Infrastructure's Infrastructure for Jobs and Prosperity Act – Asset Management Planning for Municipal Infrastructure (O. Reg 588/17).

**Prepared for:  
The Municipality of West Nipissing**

Community Services  
2022-2031 Asset Management Plan  
Summary

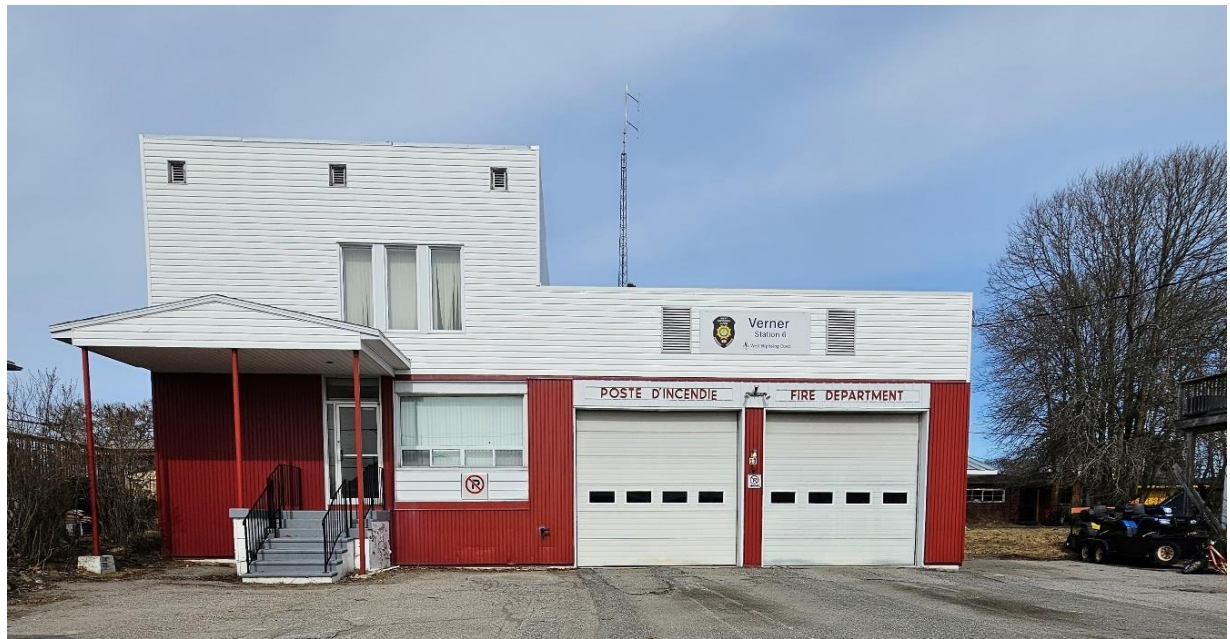
Station Name: **Station 6 Verner**

In-Service Date:	Built 1963 Acquired in Amalgamation 1999		
Description:	This facility is used to stage and deploy equipment and apparatus for the Verner response area. This facility is equipped with a SCBA refilling station, office, and storage area. There is ample room to safely maneuver equipment and resources.		
Bays:	2 back-in bays	Apparatus and Light-Duty Vehicles:	1 Mini Pumper, 1 Tanker
Comments:	<p>There is room inside and outside of the facility to conduct some hands-on training. Currently, this facility is serving its purpose and the area well. At present, this facility is at capacity.</p> <p><b>Note:</b> Currently, this facility is under review.</p>

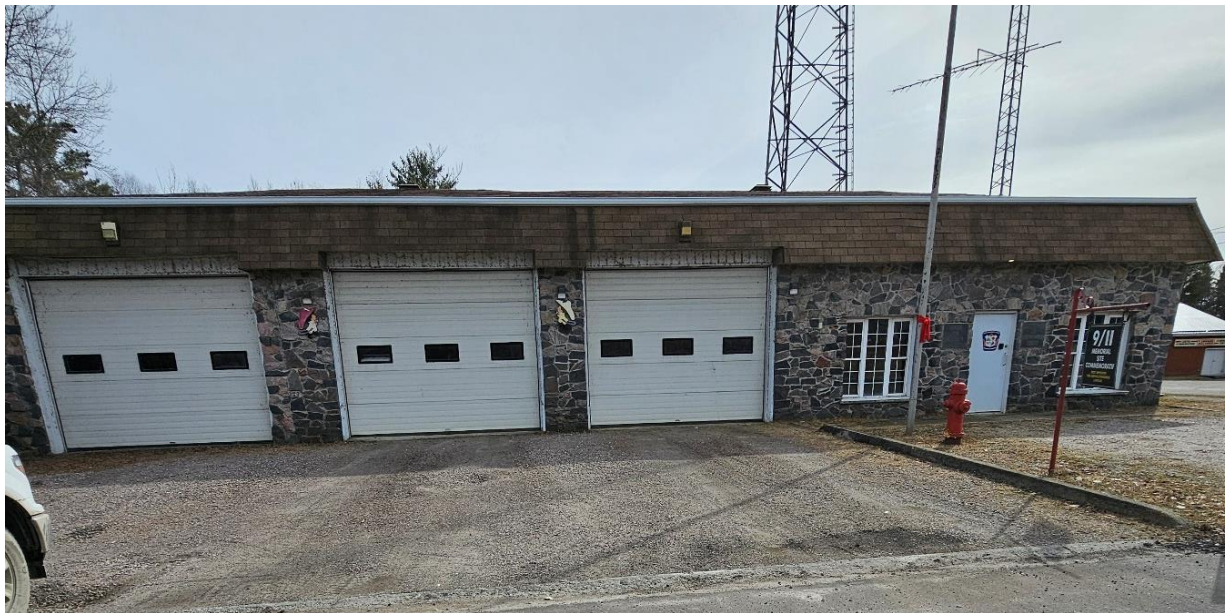
Station Name:		Station 7 Lavigne

In-Service Date:		Built 1974 Acquired in Amalgamation 1999	
Description:		This facility is used to stage and deploy equipment and apparatus for the Lavigne response area. There is room inside and outside of the facility to conduct some limited hands-on training. This facility is equipped with a SCBA refilling station, office, and storage area.	
Bays:		3 back-in bays	Apparatus and Light-Duty Vehicles: 1 Tanker, 1 Pumper
Comments:		There is ample room inside to safely maneuver equipment and resources, however access in front of the building requires extreme care and attention due to its location on a sharp bend in the road. There is room outside the facility to conduct limited hands-on training. At present, this facility is at capacity. <b>Note:</b> Currently, this facility is under review.

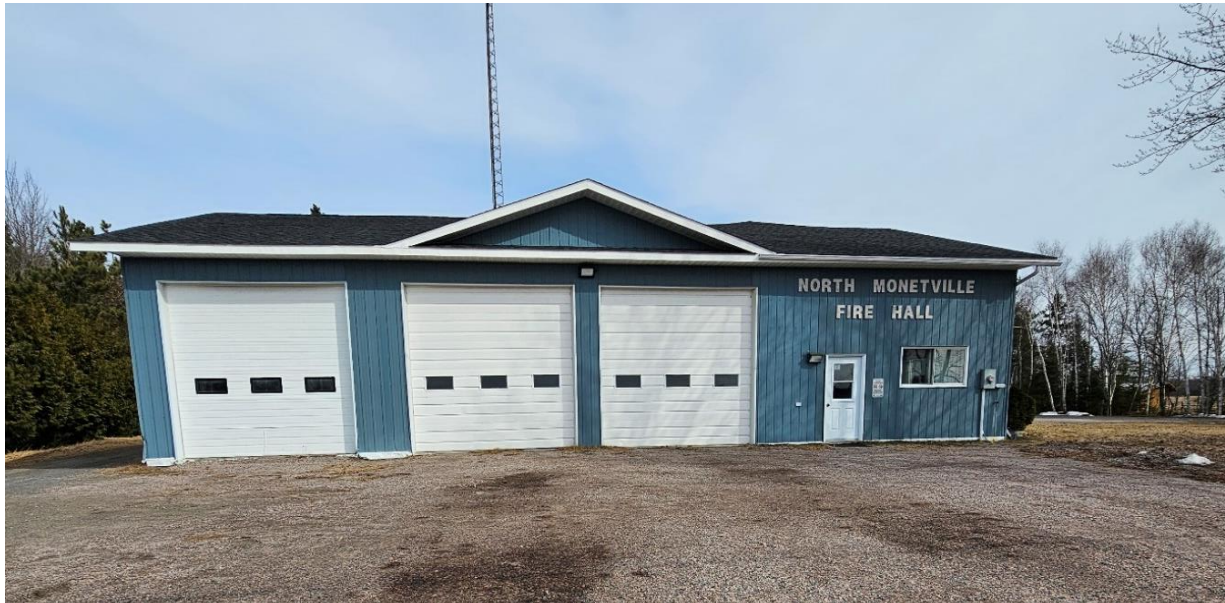
Station Name:		Station 8 North Monetville

In-Service Date:		Built 1993 Acquired in Amalgamation 1999	
Description:		This facility is used to stage and deploy equipment and apparatus for the North Monetville response area. This facility is equipped with a SCBA refilling station, office, and storage area.	
Bays:		2 back-in bays	Apparatus and Light-Duty Vehicles: 1 Mini Pumper, 1 Tanker
Comments:		Currently, this facility is serving its purpose and the area well. There is room outside of the facility to conduct some hands-on training. There is, however, limited room to safely maneuver equipment and resources. At present, this facility is at capacity. <b>Note:</b> Currently, this facility is under review.

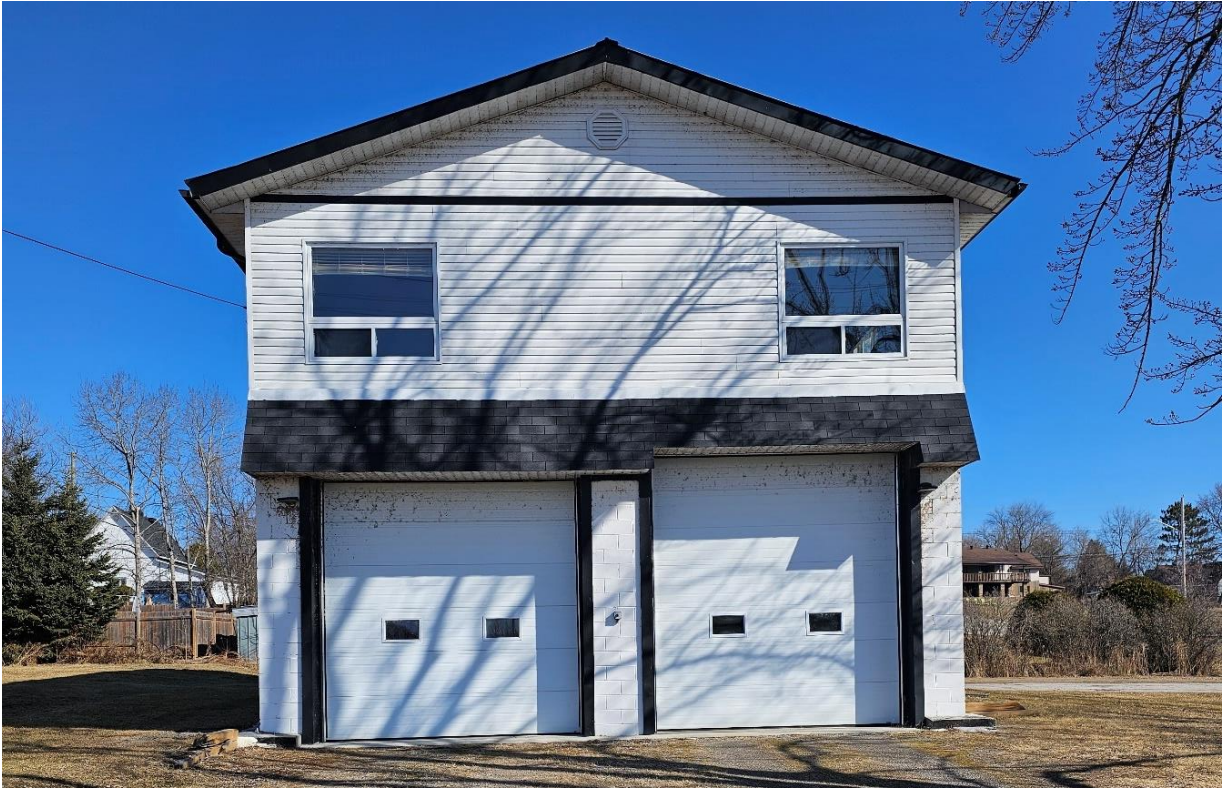
Station Name: **Station 9 Cache Bay**

In-Service Date:	Built 1977 Acquired in Amalgamation 1999		
Description:	This facility is used to stage and deploy equipment and apparatus for the Cache Bay response area. This facility is equipped with a SCBA refilling station, office, and storage area.		
Bays:	2 back-in bays	Apparatus and Light-Duty Vehicles:	1 Pumper
Comments:	<p>There is room outside of the facility to conduct some hands-on training. There is ample room to safely maneuver equipment and resources. This facility is equipped with a classroom and lounge area. At present, this facility is at capacity.</p> <p><b>Note:</b> Currently, this facility is under review.</p>
